# Full View

Aerial Imaging Solutions

Re: Report of the overall external roof condition at

Please see below a survey of the recent roof works undertaken at the above named property.

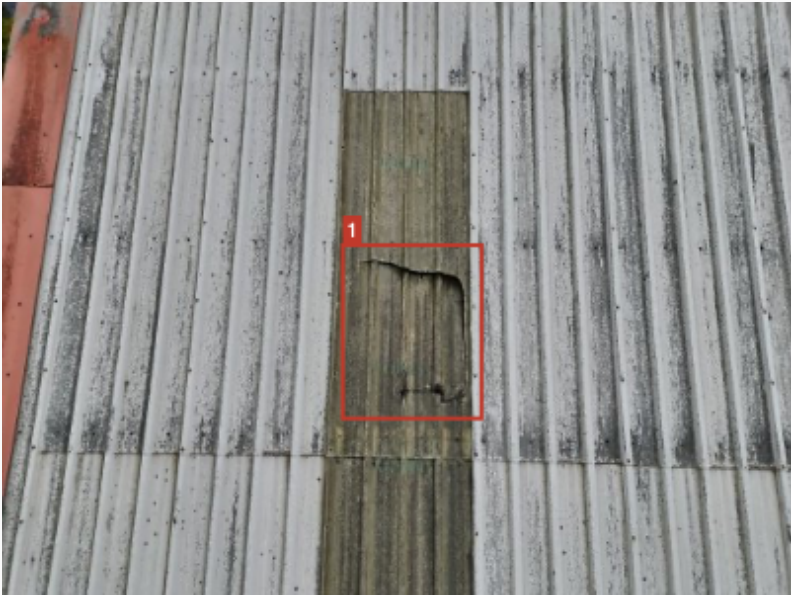
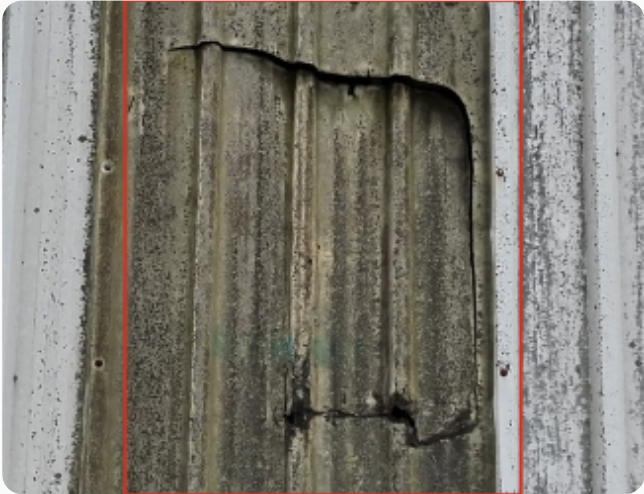
# 1

GRP roof lights are present throughout and are considered to be nearing the end of their serviceable lifespan. Prolonged exposure to ultraviolet (UV) radiation has caused the material to become brittle, increasing the likelihood of cracking, failure, and associated water ingress. In one instance, a roof light has failed completely, leaving an open point of ingress where water penetration into the building will be certain during periods of rainfall. The widespread ageing and deterioration of the roof lights indicates that further failures are likely if remedial works are not undertaken.

Severity 5

Damage

**Alex Herman**  
Damaged GRP roof light

- Replace all deteriorated GRP roof lights with new units of equivalent specification
- Prioritise the roof light that has already failed completely
- Install all replacement roof lights with new seals, fixings, and weathering details
- Review the condition of surrounding roof sheets and support details during replacement works

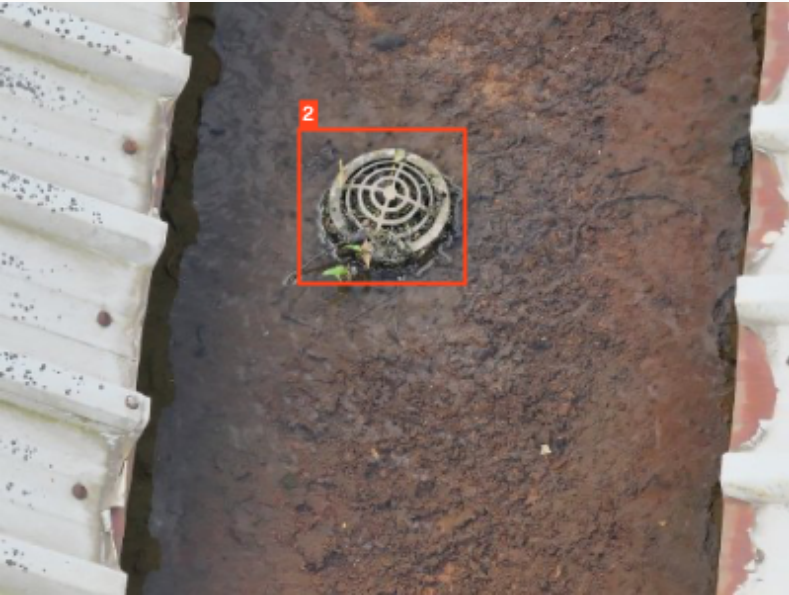
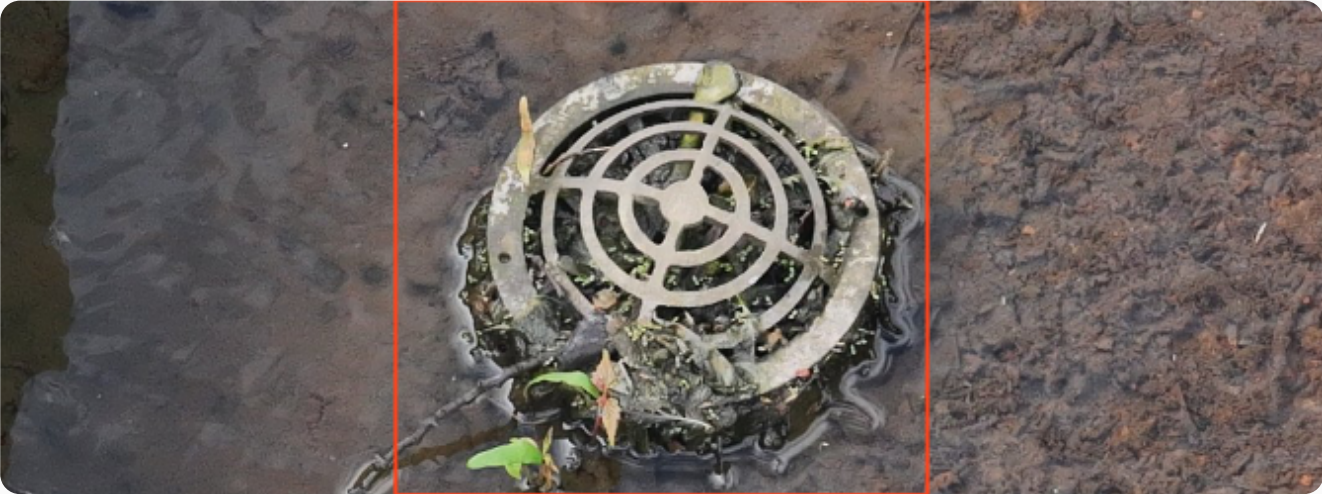
# 2

The rainwater goods are currently in a poor state of maintenance. Gutters are heavily obstructed with debris and vegetation. This level of blockage will significantly impede the effective discharge of rainwater, leading to overflow, increased loading on the gutter system, and a heightened risk of water ingress at eaves level.

Severity 4

Debris

- Remove all debris, vegetation, and organic growth from gutters and outlets
- Clean and inspect all box gutters for corrosion and localised failure
- Undertake repairs or localised replacement of corroded gutter sections where required
- Extend or renew gutter lining systems where deterioration is advanced
- Implement a planned maintenance regime including regular gutter clearance

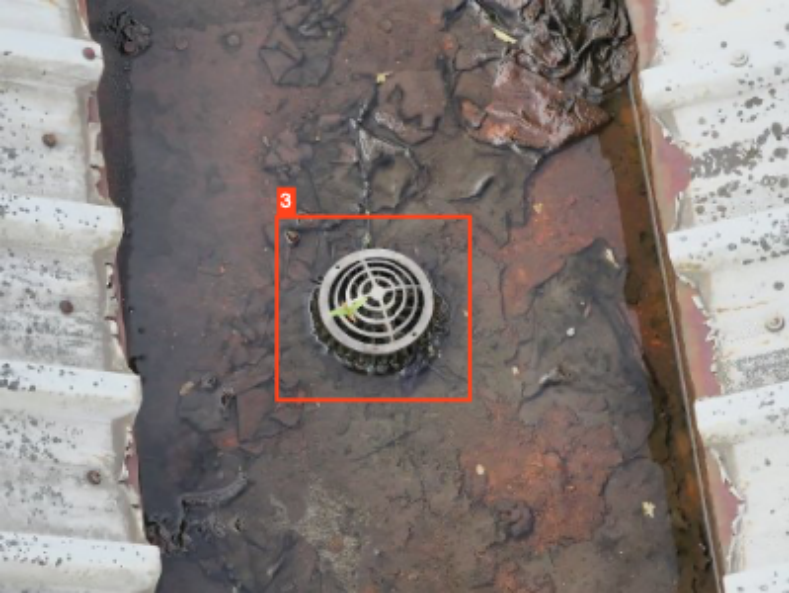
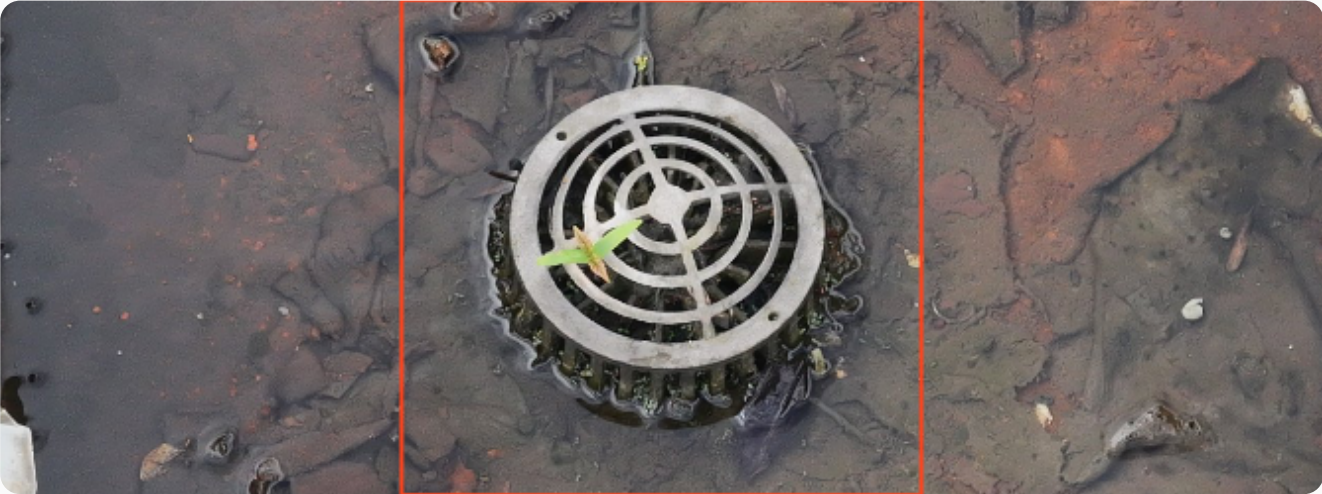
# 3

Severity 4

Debris

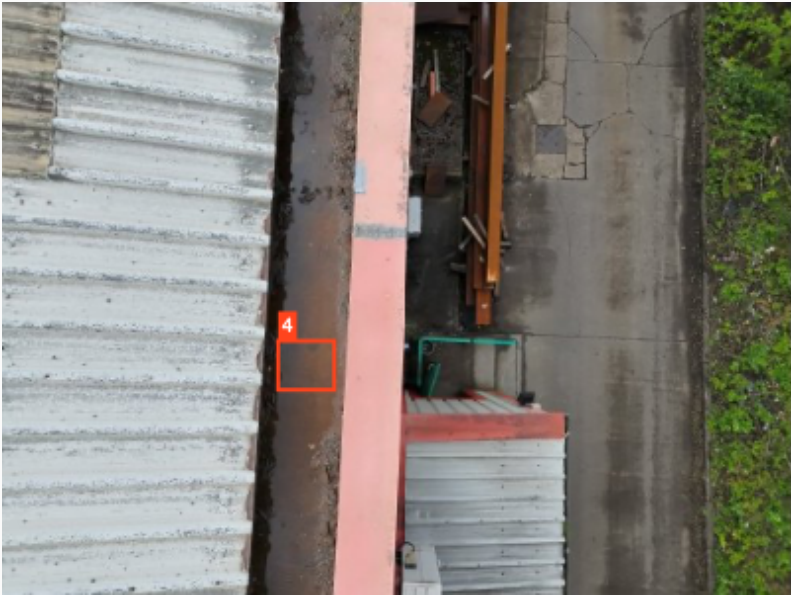
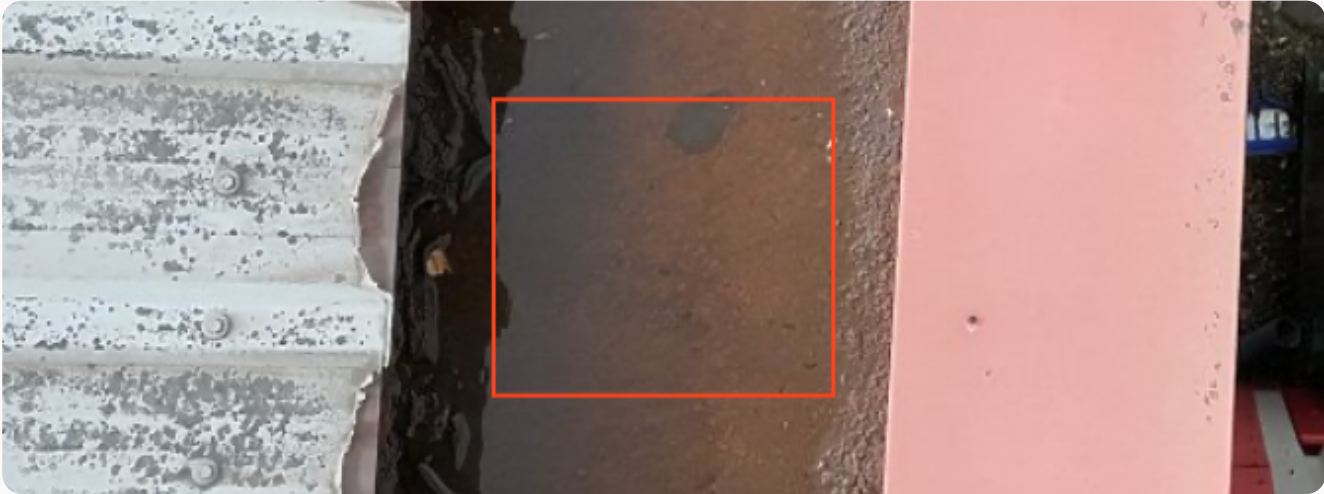
# 4

Corrosion is also evident within the box gutters. Although isolated sections have been fitted with a gutter lining system, the majority of the box gutters remain untreated and exposed to ongoing deterioration. The presence of corrosion, combined with inadequate maintenance and substantial debris accumulation, increases the likelihood of localised failure and water ingress occurring within the gutter system.

Severity 4

Gutter corrosion

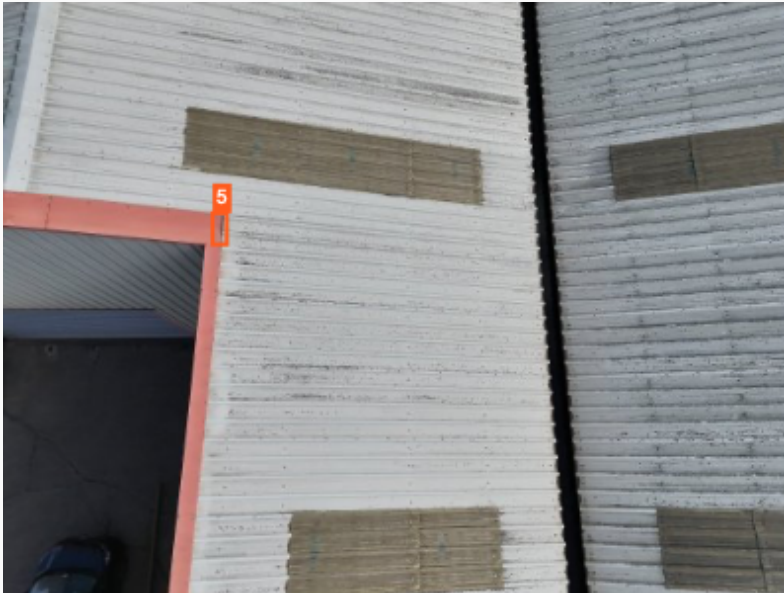
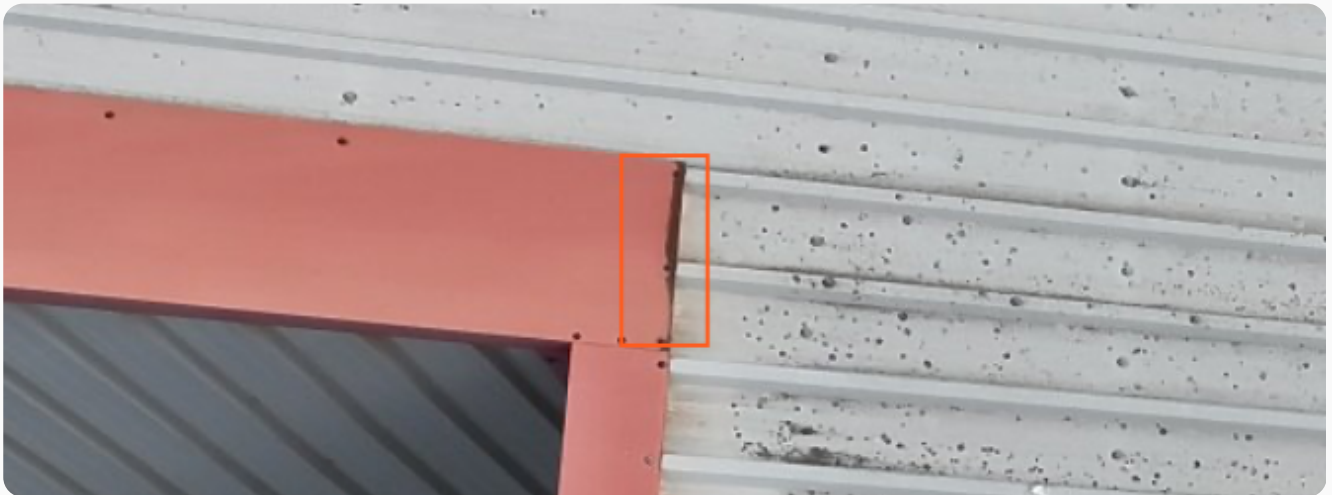
# 5

The roof covering comprises profiled metal roof sheets which are generally in good overall condition. However, there are early signs of cut edge corrosion visible at the mid and end laps of a number of sheets.

Severity 3

Cut edge corrosion

- Mechanically prepare all affected cut edges to remove oxidation and corrosion products back to a sound substrate
- Apply a compatible anti-corrosion primer system to all prepared areas
- Overcoat affected sheet edges, laps, and fixings using a compatible high-performance coating system
- Replace all loose, missing, or perished fixings with new compatible fasteners complete with weather seals and washers
- Inspect all adjacent sheet laps and interfaces for early signs of moisture ingress or coating failure

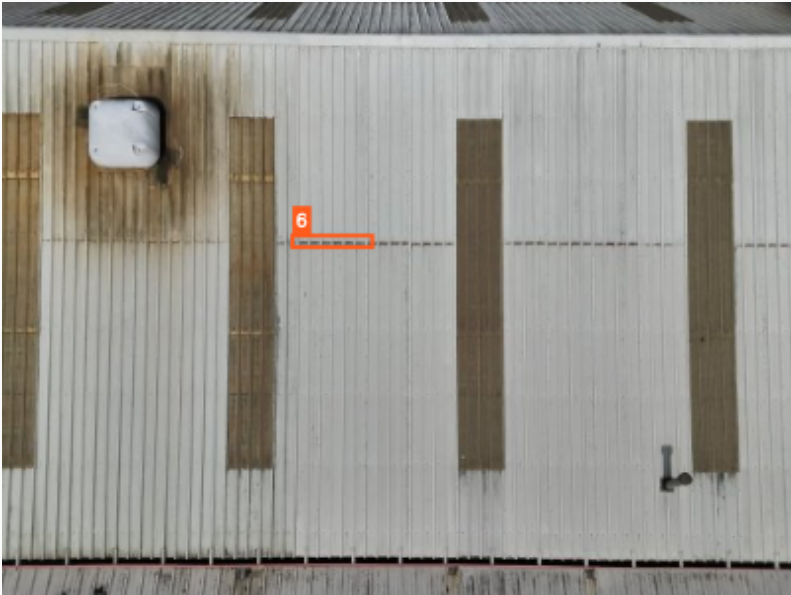
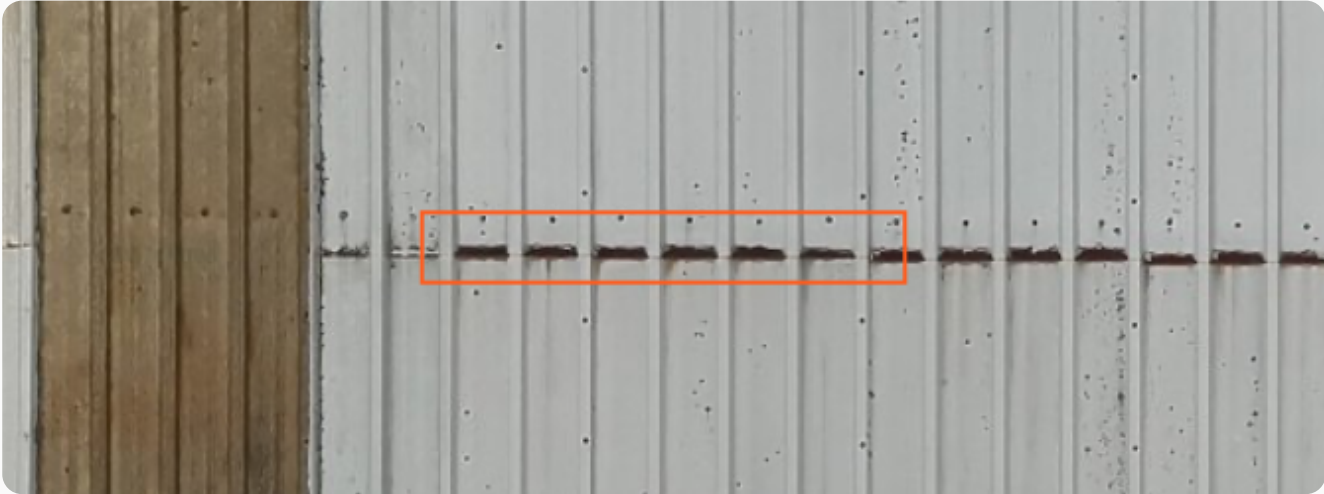
# 6

Severity 3

Cut edge corrosion

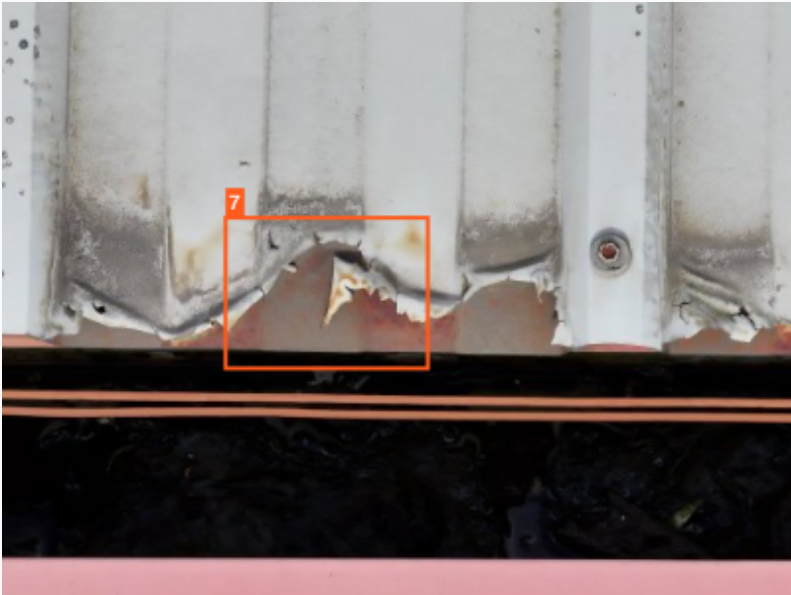
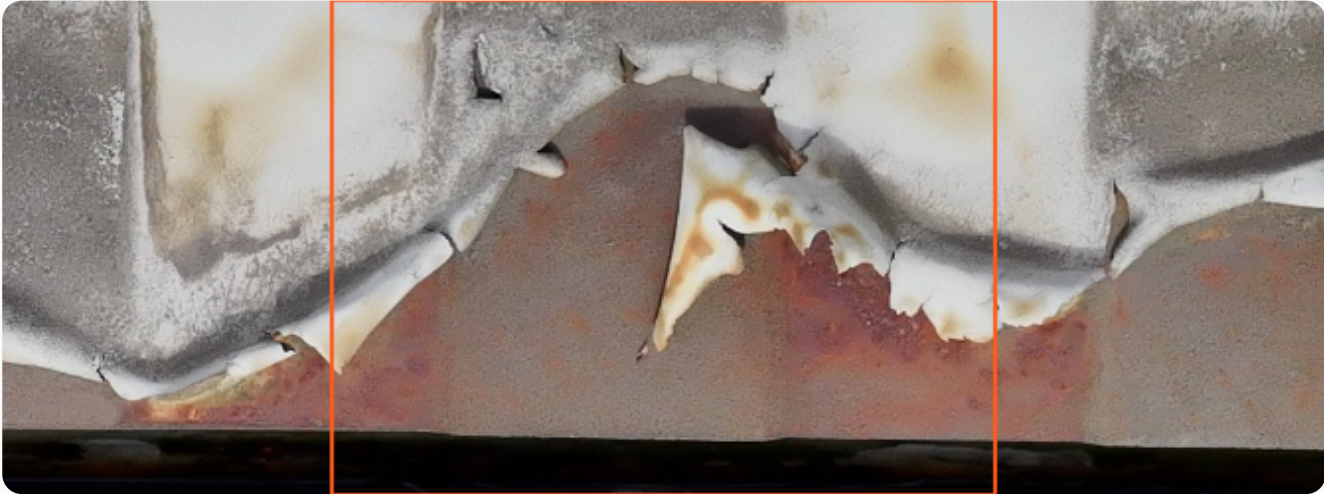
# 7

Severity 3

Cut edge corrosion

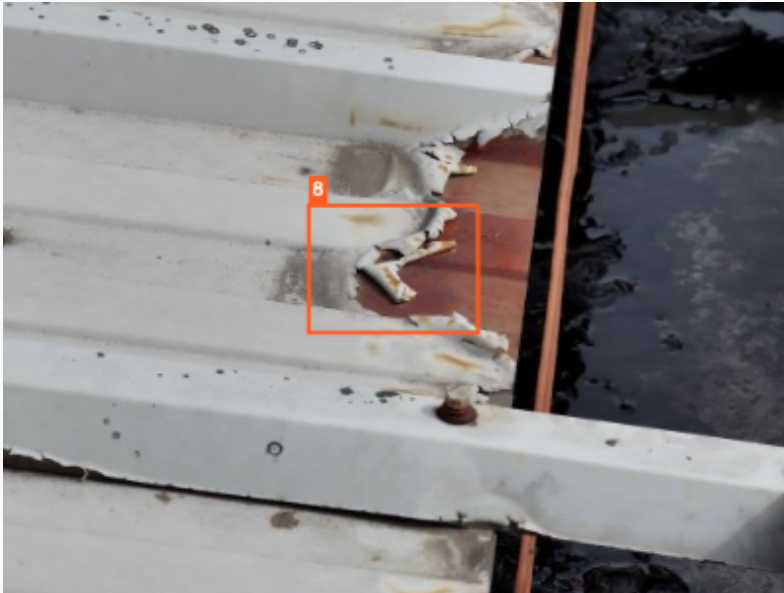
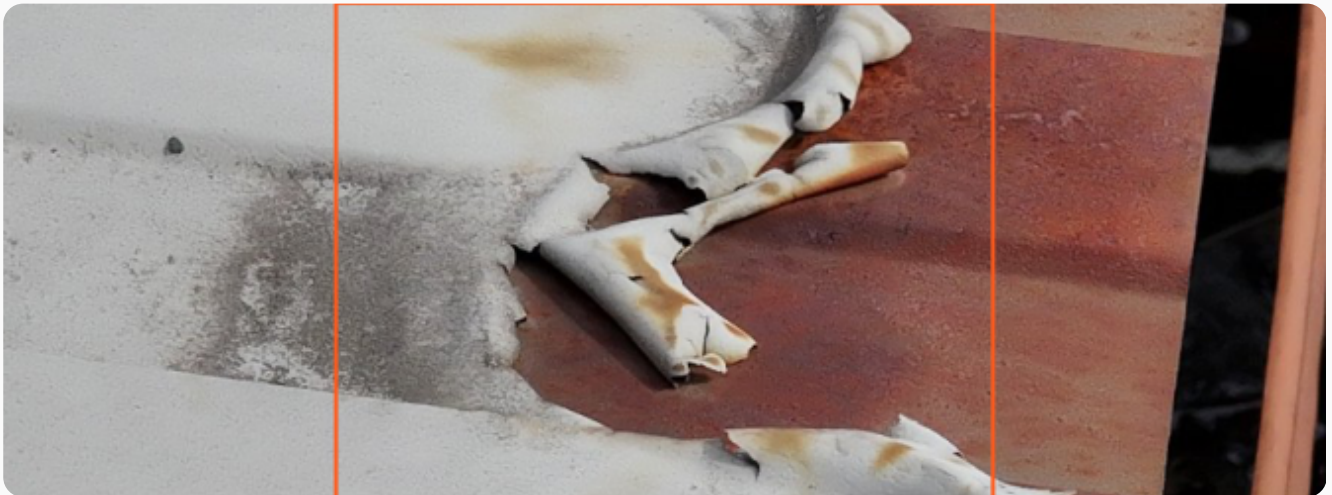
# 8

Severity 3

Cut edge corrosion

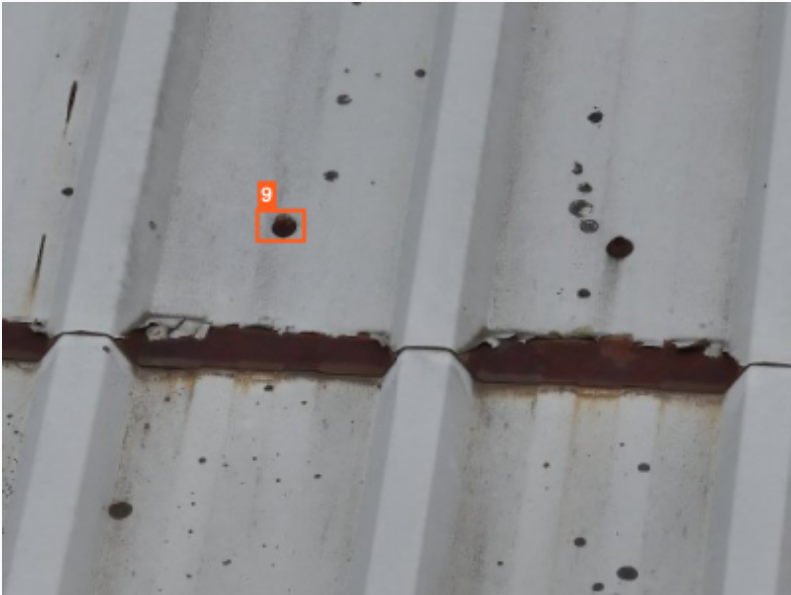
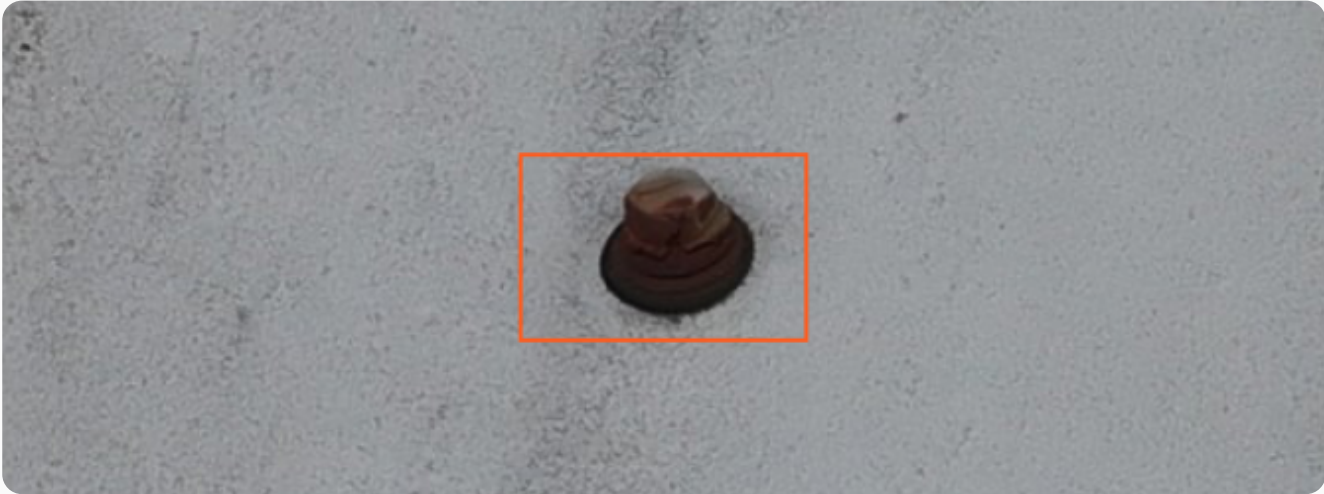
# 9

The roof fixings are in a varied condition, with a number noted as perished, loose, or missing. This presents a risk to the integrity and stability of the roof covering, particularly under adverse weather conditions, and increases the potential for water ingress.

Severity 3

Perished fixings

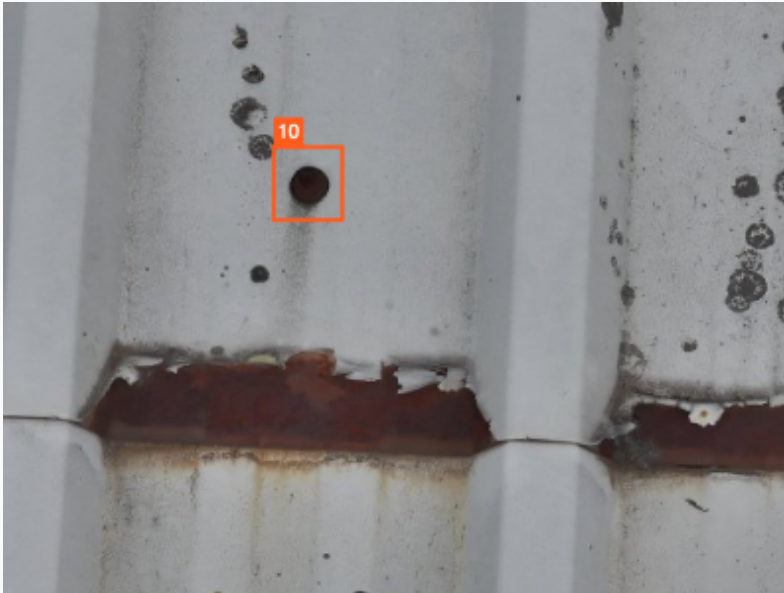
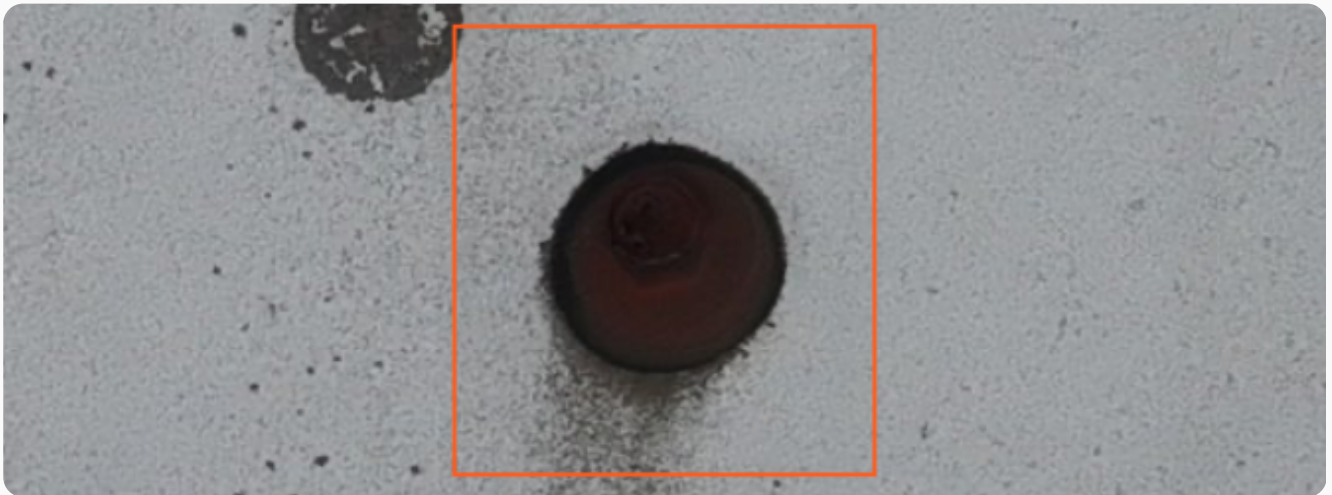
# 10

Severity 3

Perished fixings

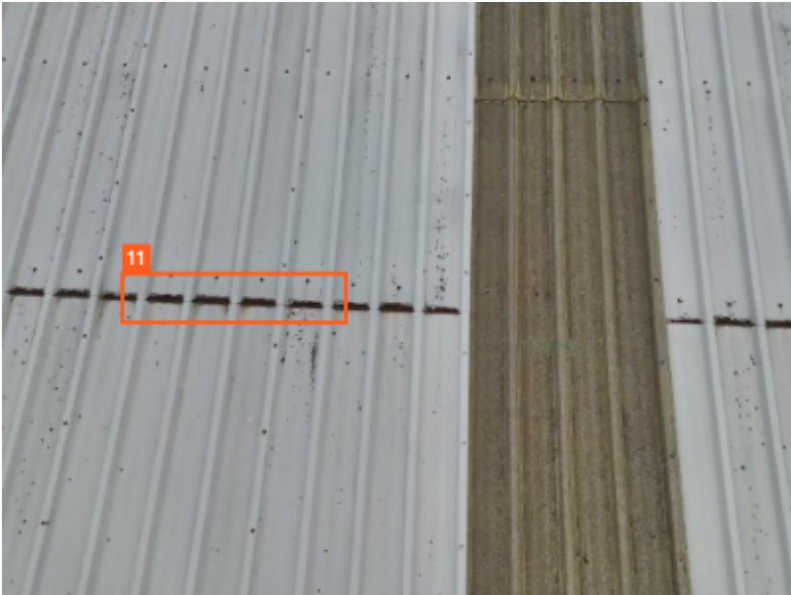
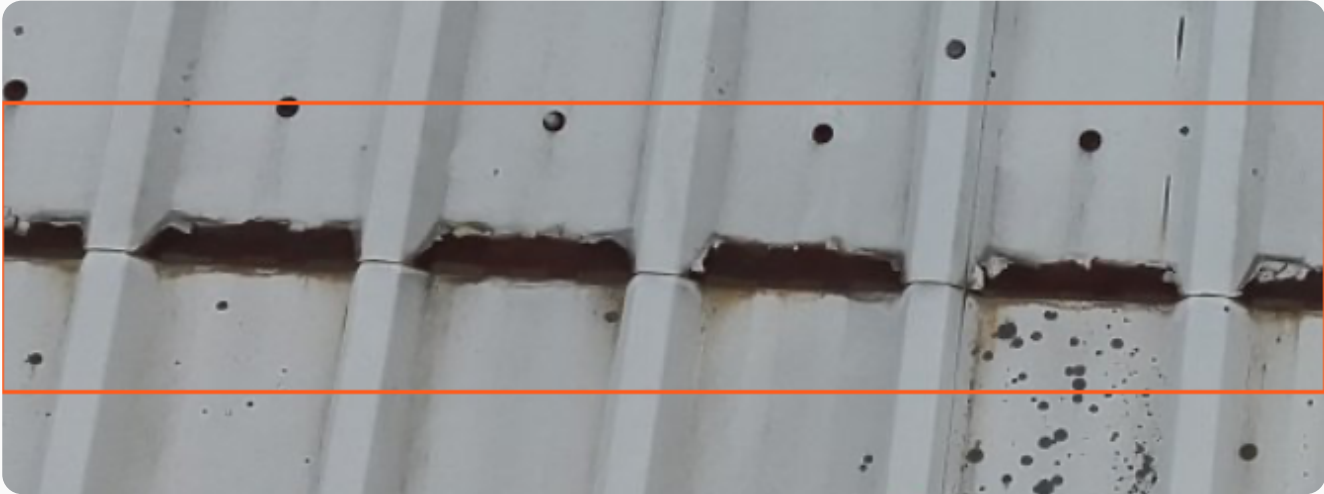
# 11

Severity 3

Cut edge corrosion

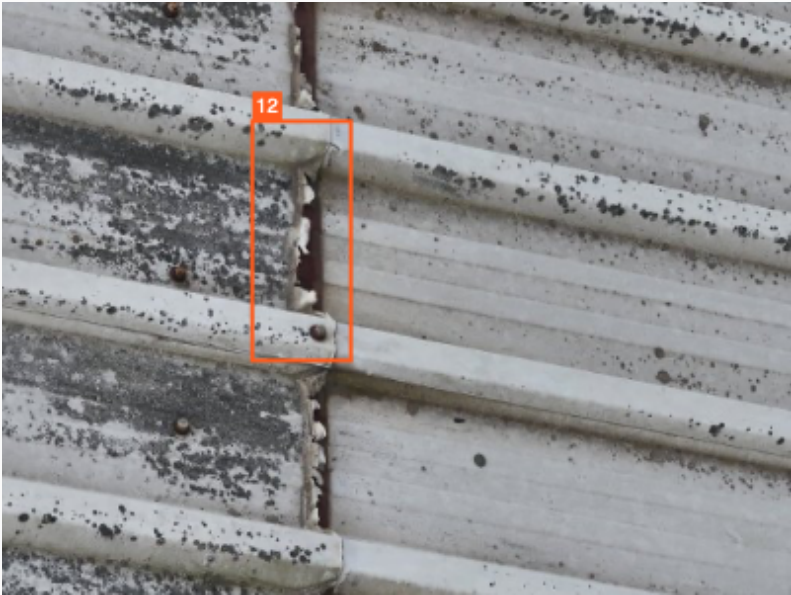
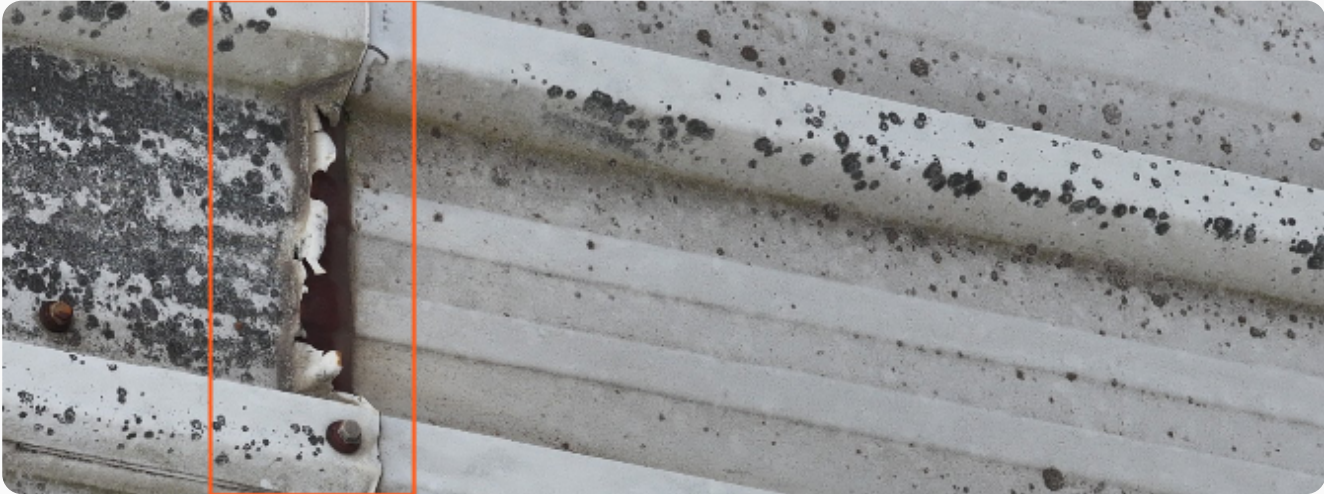
# 12

Severity 3

Cut edge corrosion

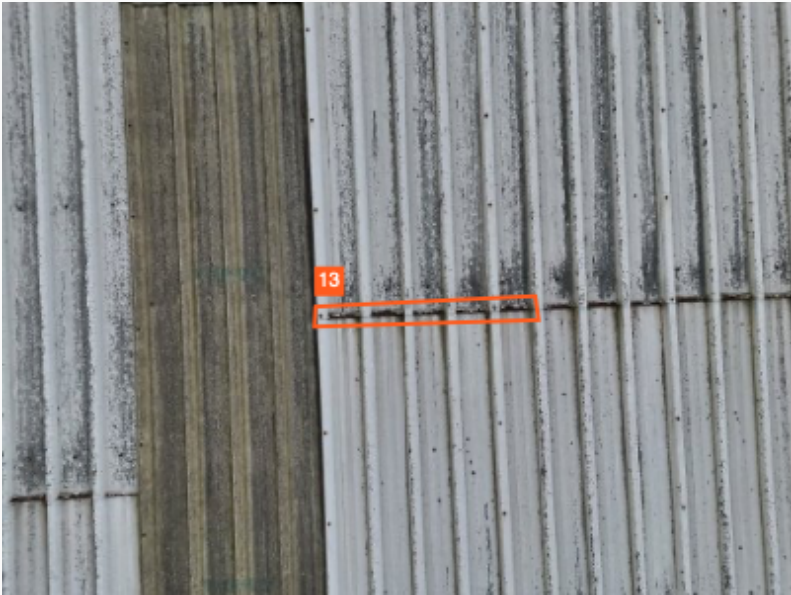
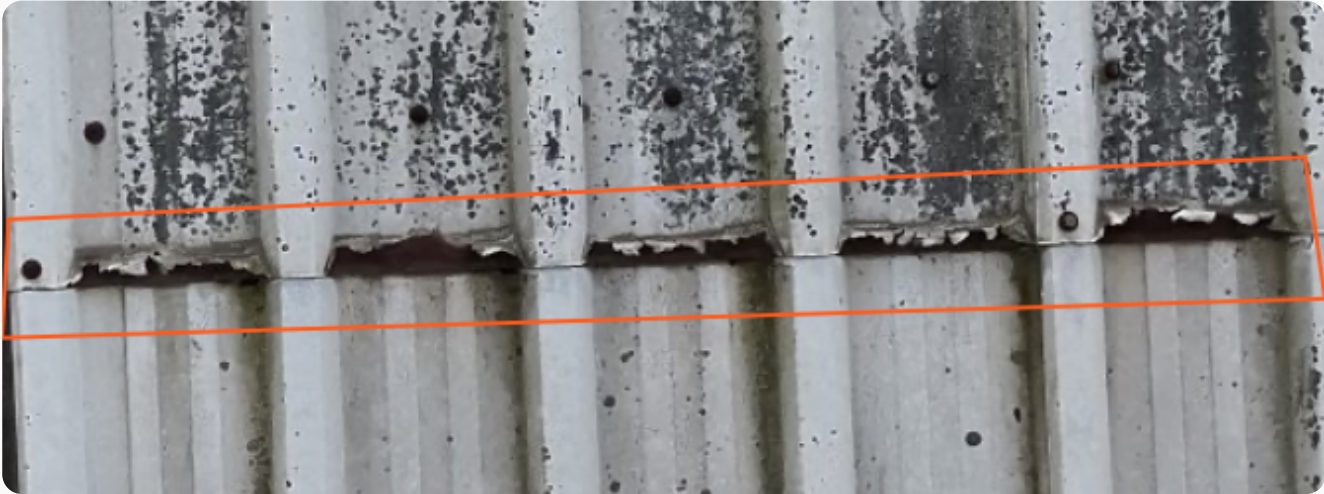
# 13

Severity 3

Cut edge corrosion

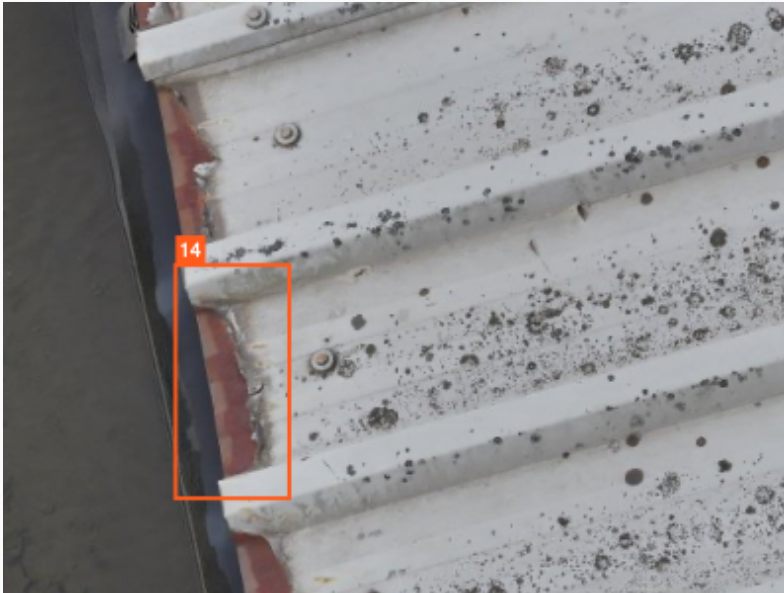
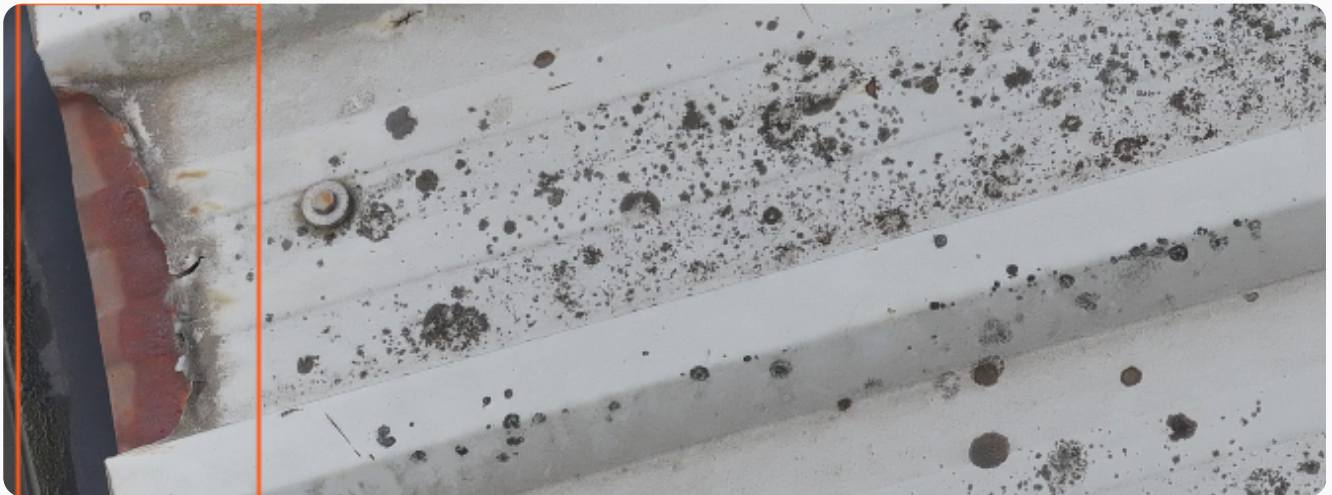
# 14

Severity 3

Cut edge corrosion

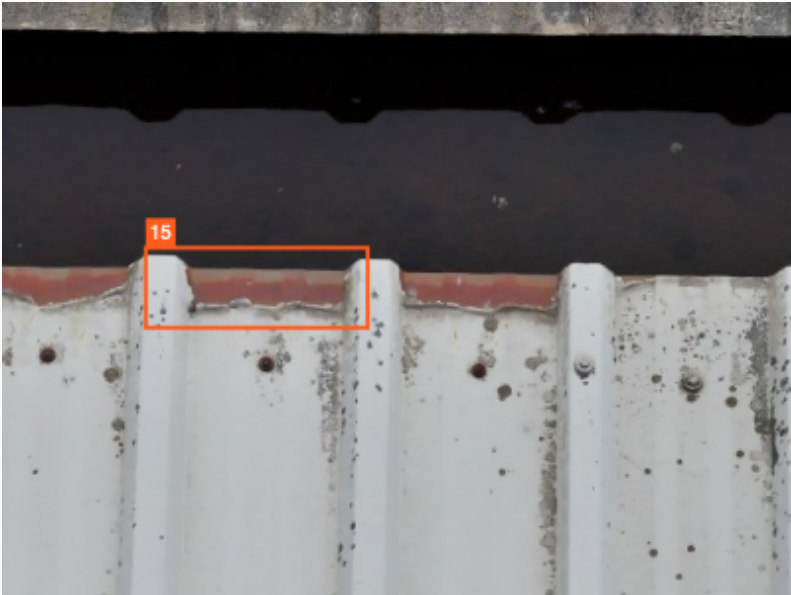
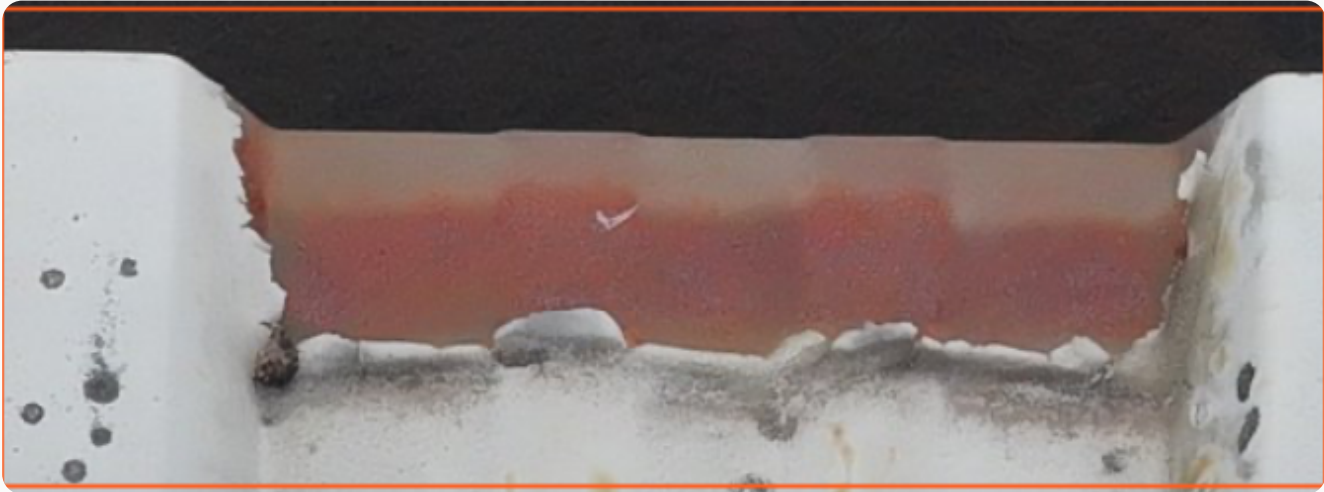
# 15

Severity 3

Cut edge corrosion

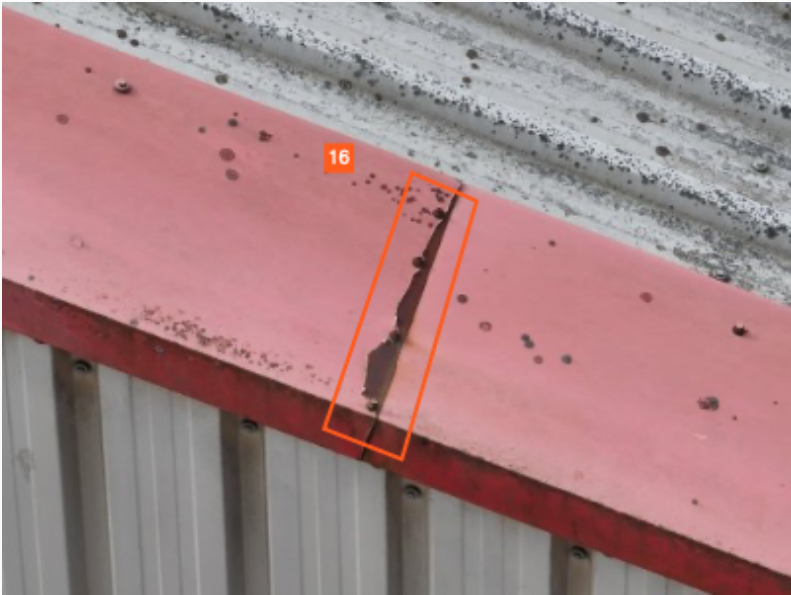
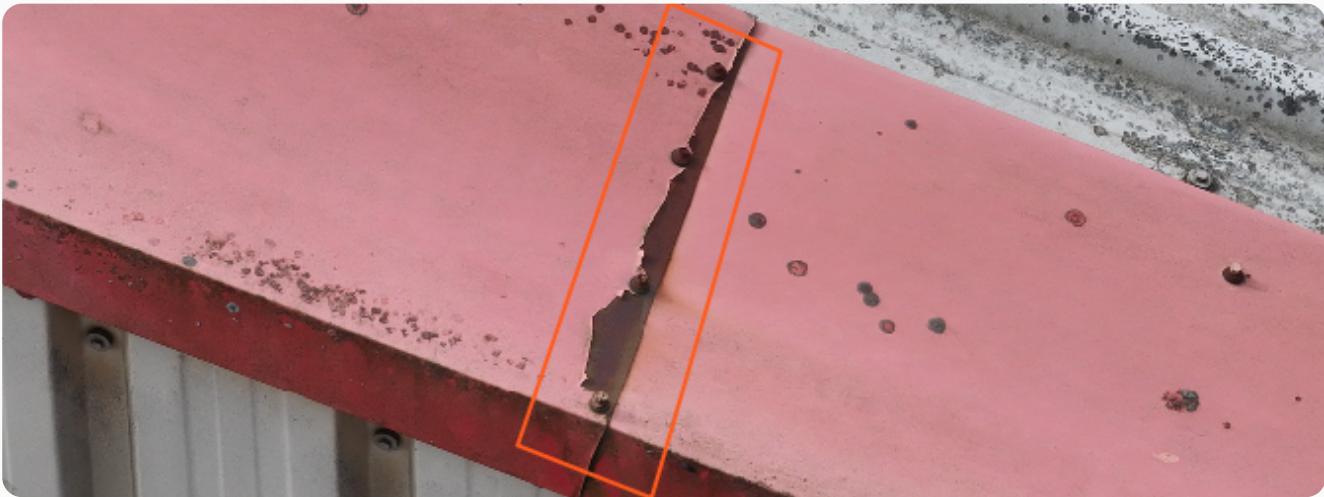
# 16

Severity 3

Cut edge corrosion

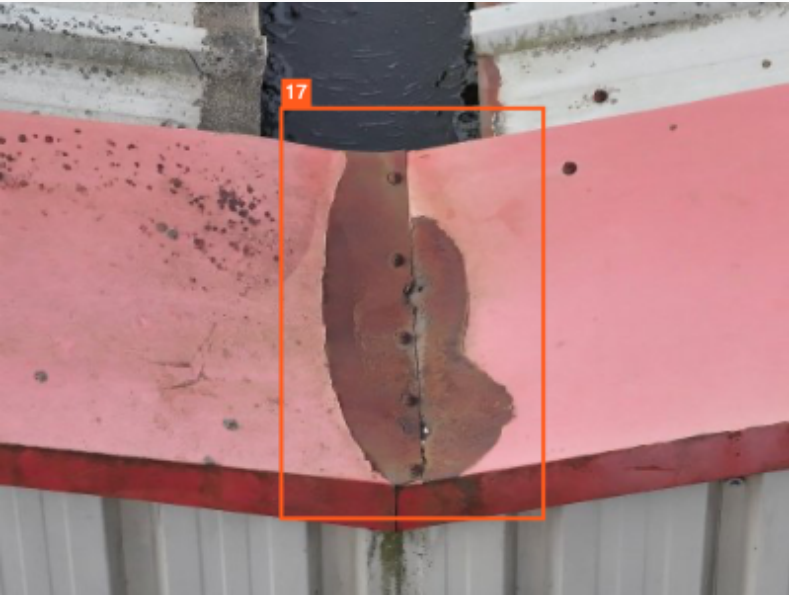
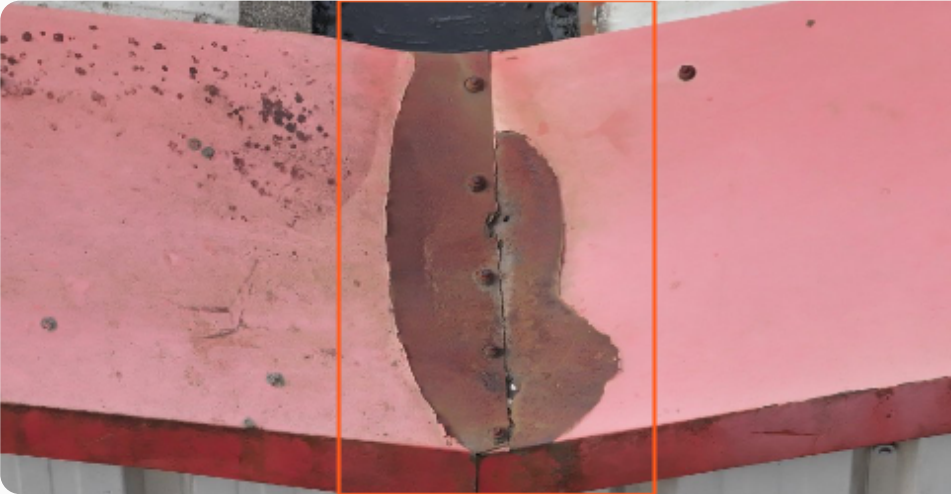
# 17

Severity 3

Cut edge corrosion

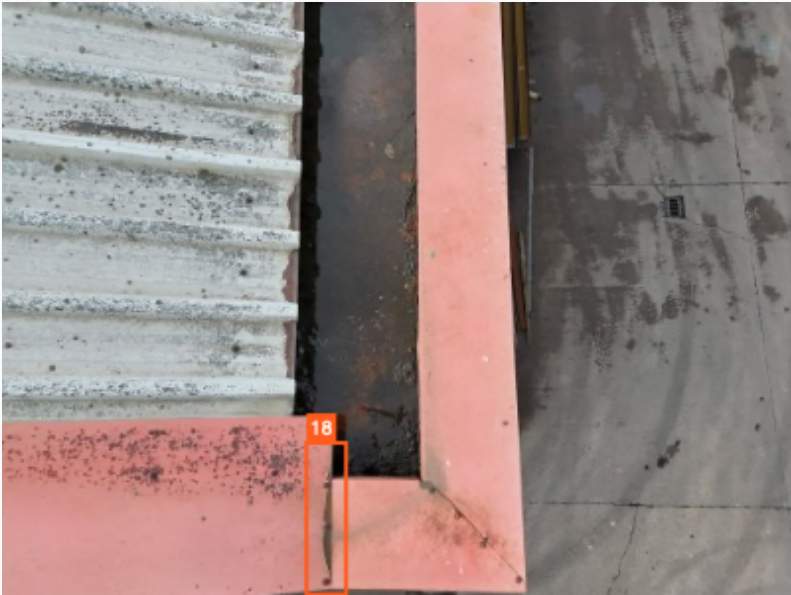
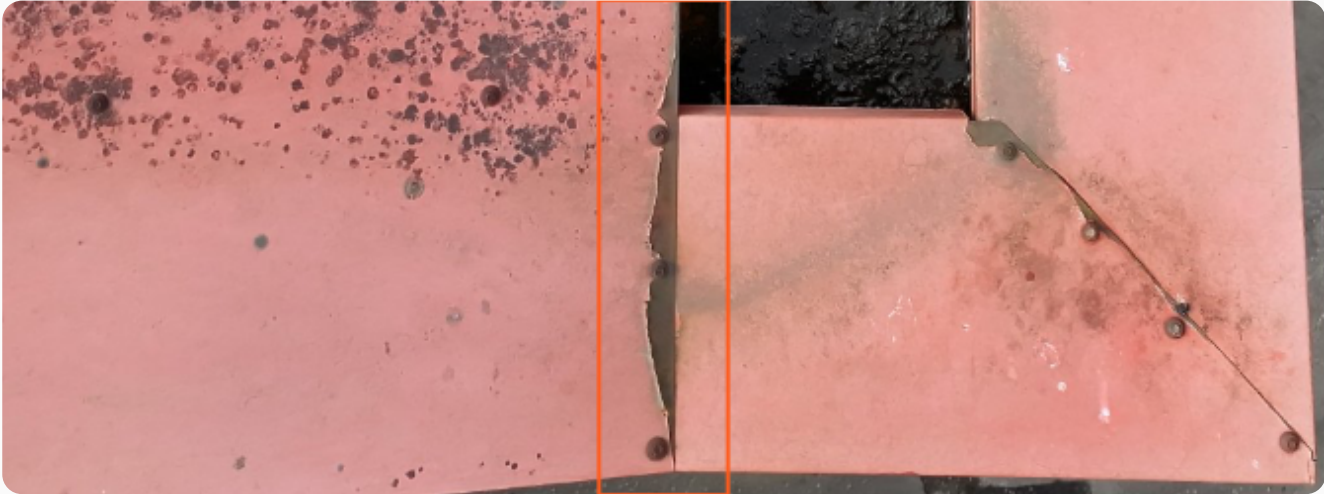
# 18

Severity 3

Cut edge corrosion

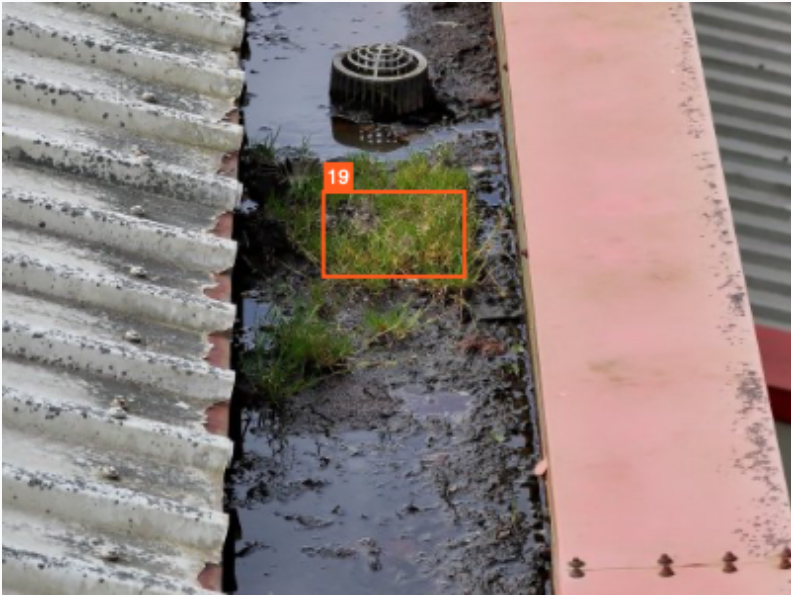
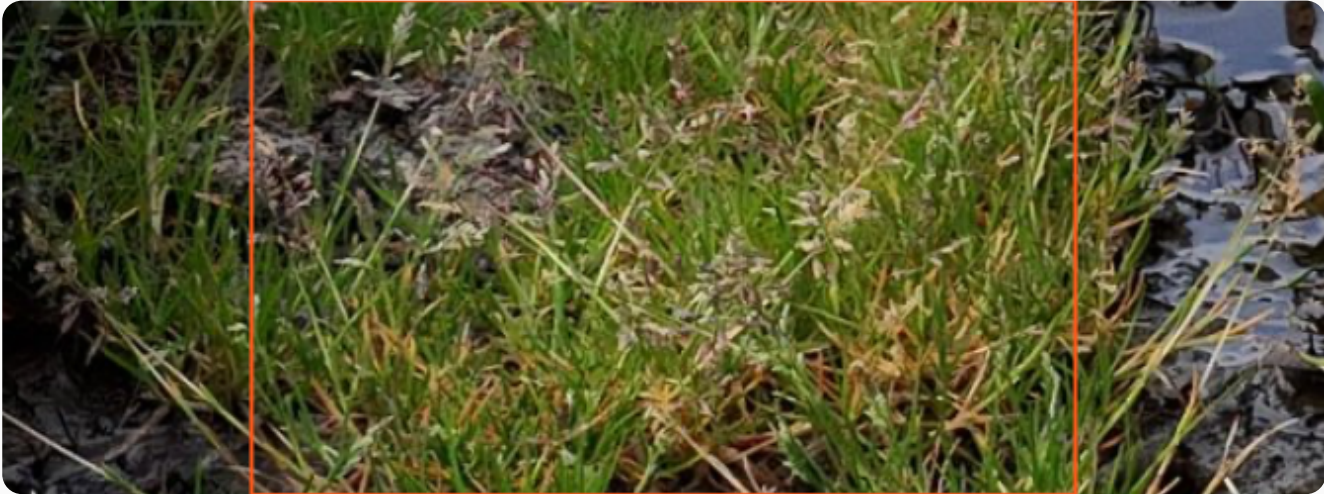
# 19

Severity 3

Vegetation

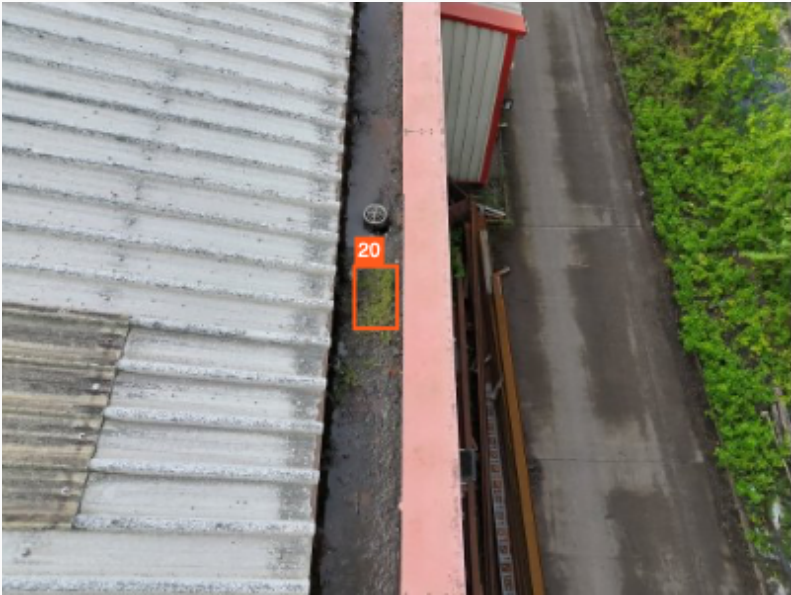
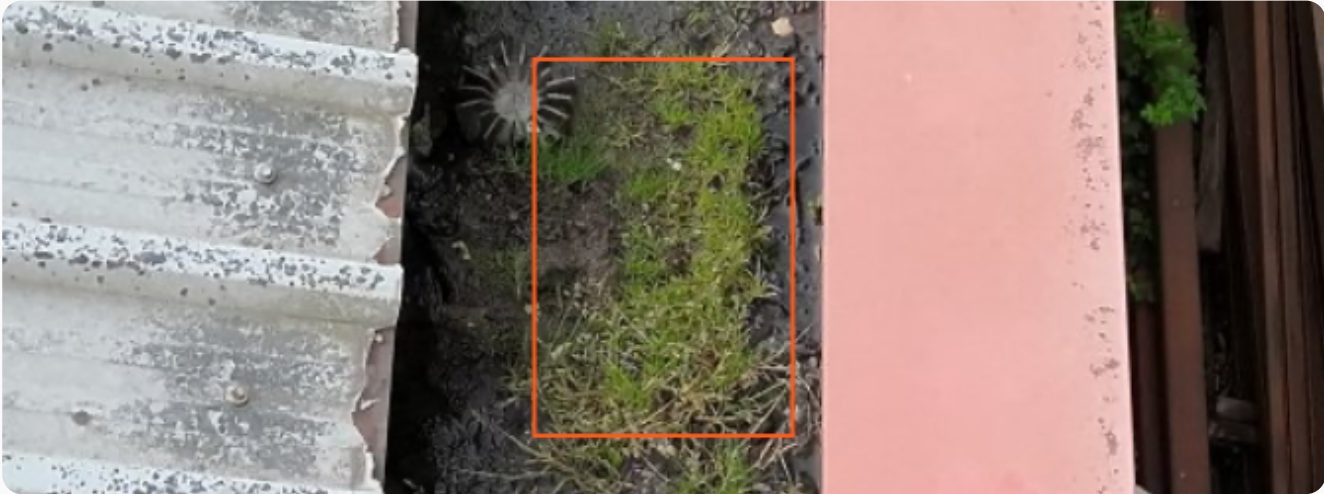
# 20

Severity 3

Vegetation
