# Full View

Aerial Imaging Solutions

Re: Report of the overall external roof condition at

Please see below a survey of the recent roof works undertaken at the above named property.

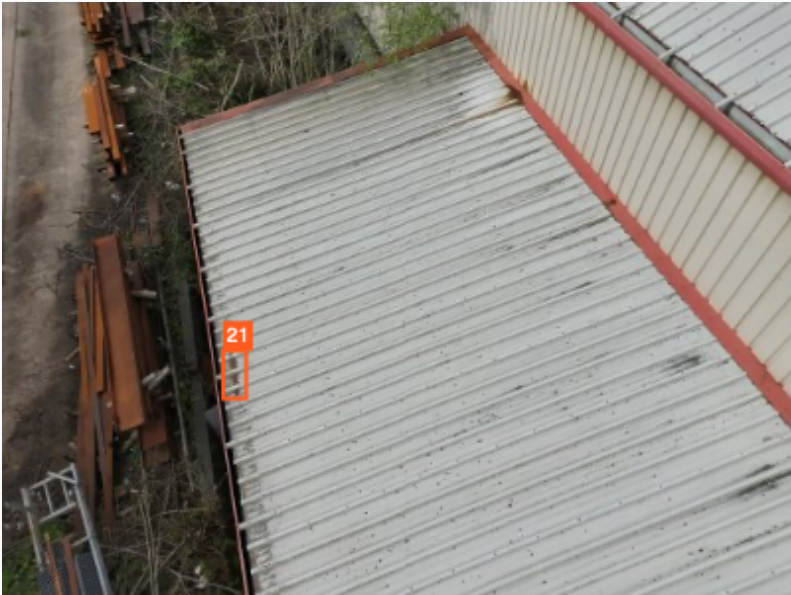
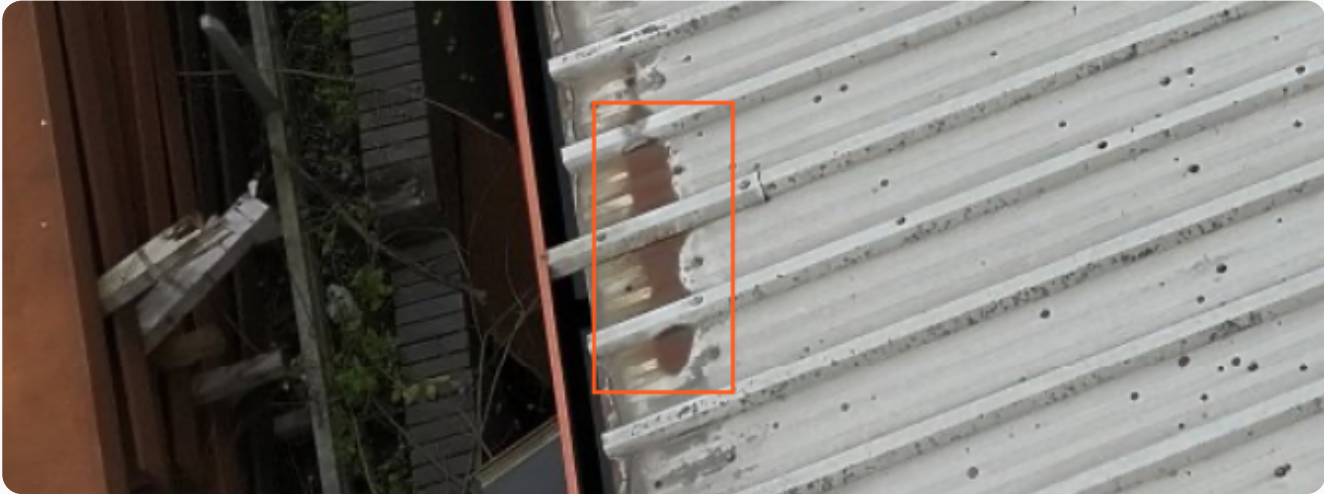
# 21

Severity 3

Cut edge corrosion

- Mechanically prepare all affected cut edges to remove oxidation and corrosion products back to a sound substrate
- Apply a compatible anti-corrosion primer system to all prepared areas
- Overcoat affected sheet edges, laps, and fixings using a compatible high-performance coating system
- Replace all loose, missing, or perished fixings with new compatible fasteners complete with weather seals and washers
- Inspect all adjacent sheet laps and interfaces for early signs of moisture ingress or coating failure

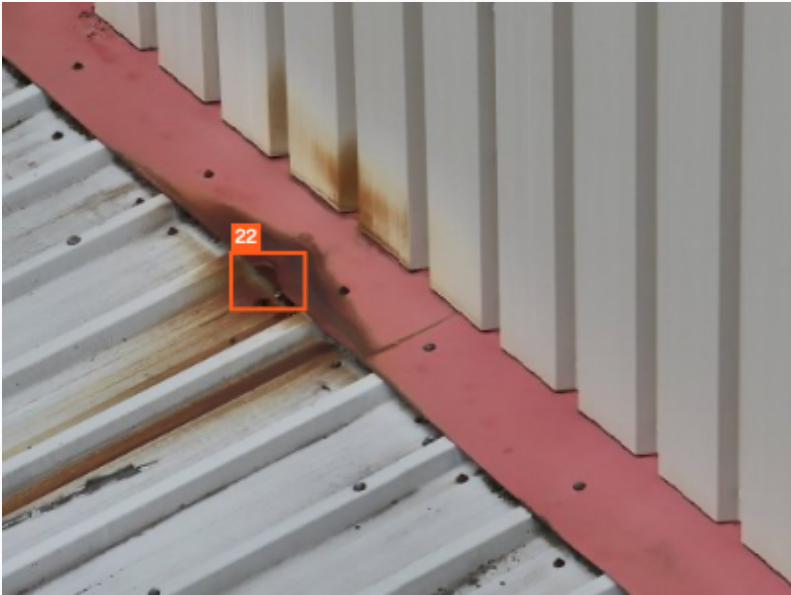
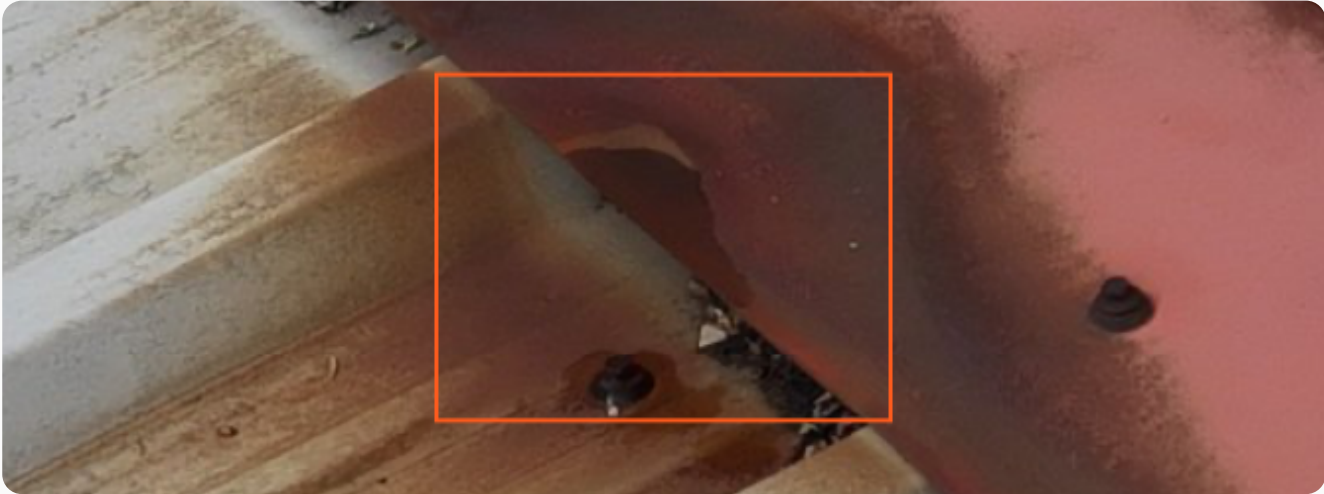
# 22

Severity 3

Corrosion

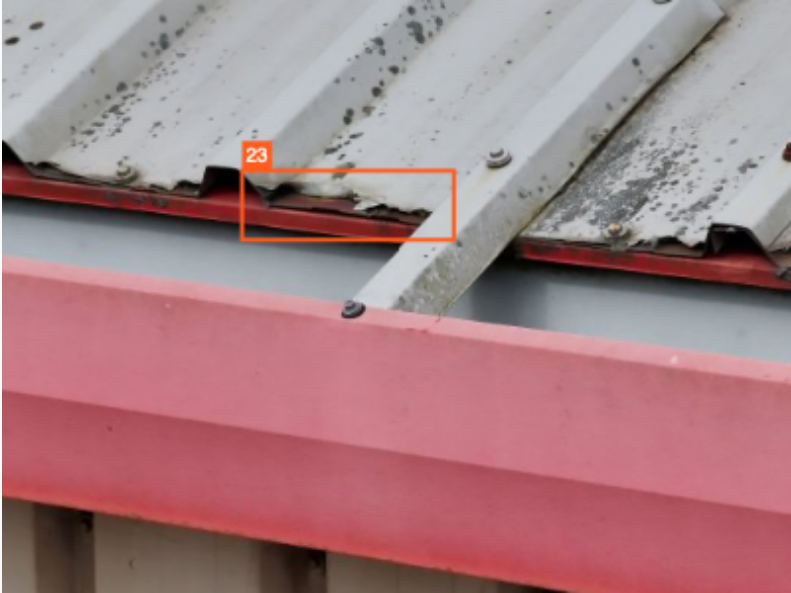
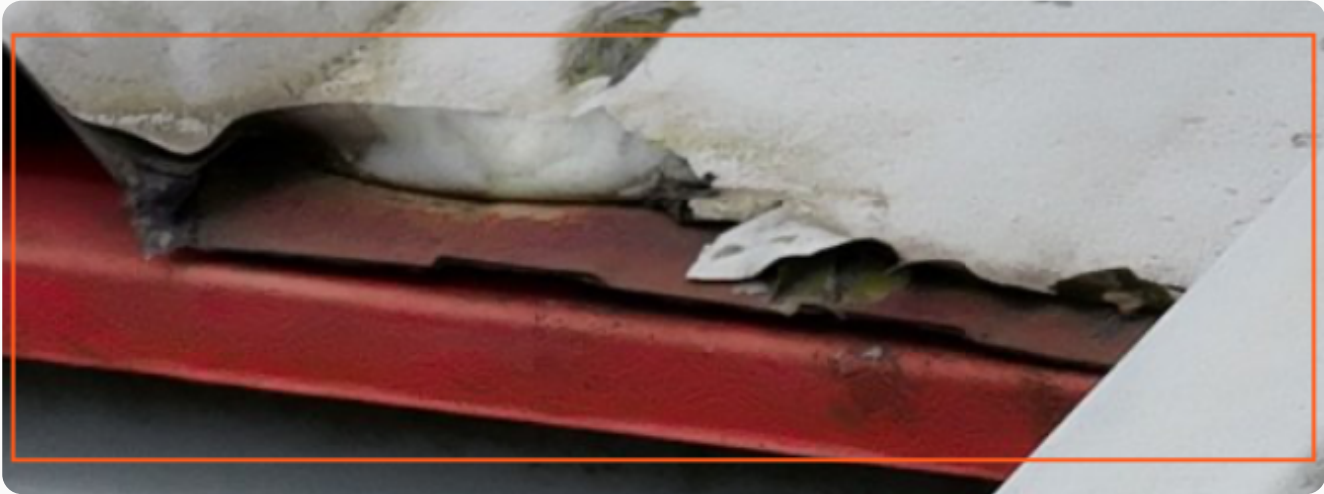
# 23

Severity 3

Cut edge corrosion

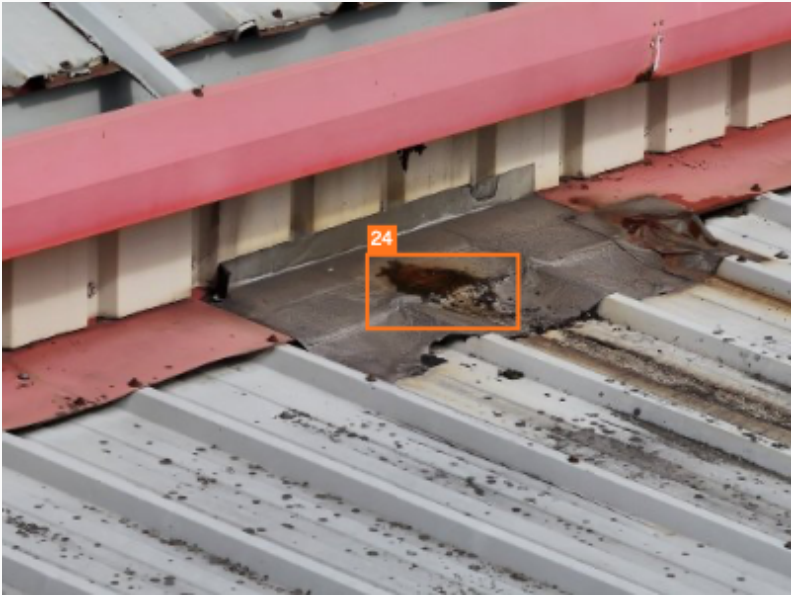
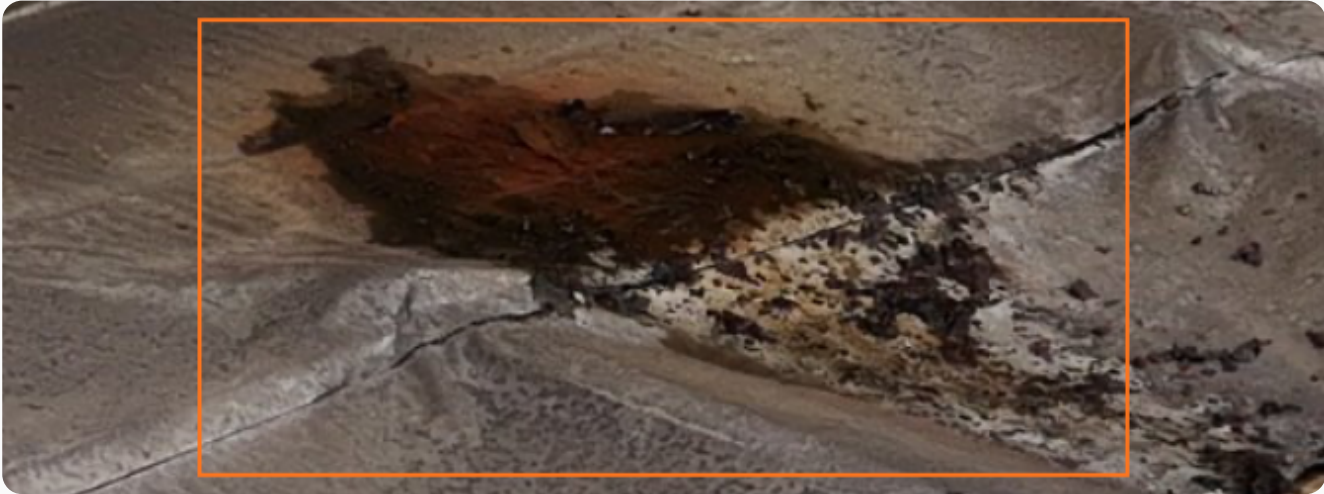
# 24

A number of temporary patch repairs were identified to the single-storey lean-to roof coverings, utilising flash band tape or similar proprietary repair materials. These repairs are considered short-term in nature and are indicative of ongoing water ingress or historic roof covering failure.

Severity 2

Existing repair

- Remove all temporary flash band or similar proprietary patch repairs
- Inspect the underlying roof sheets and substrate for concealed deterioration
- Undertake permanent repairs or localised sheet replacement where necessary
- Reinststate the roof covering using compatible materials and correctly detailed weathering systems

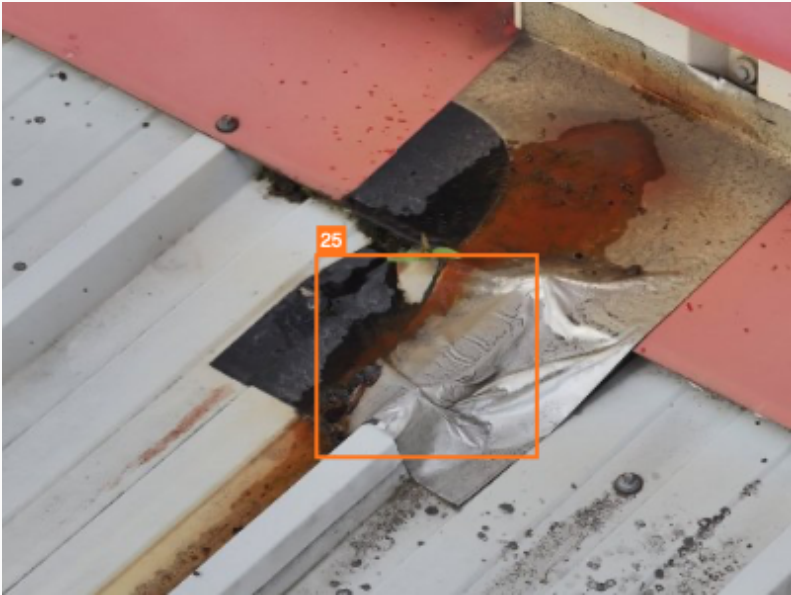
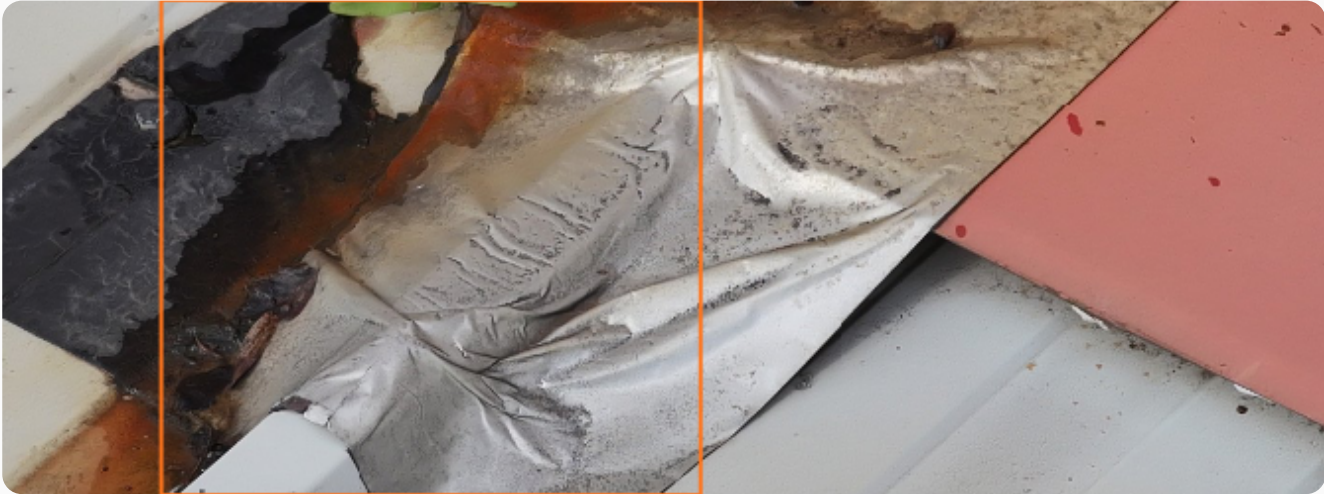
# 25

Severity 2

Existing repair

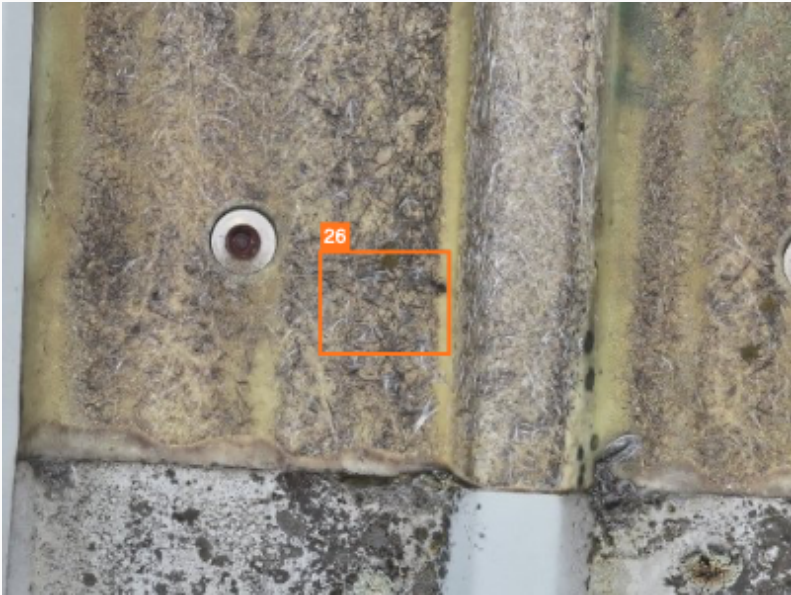
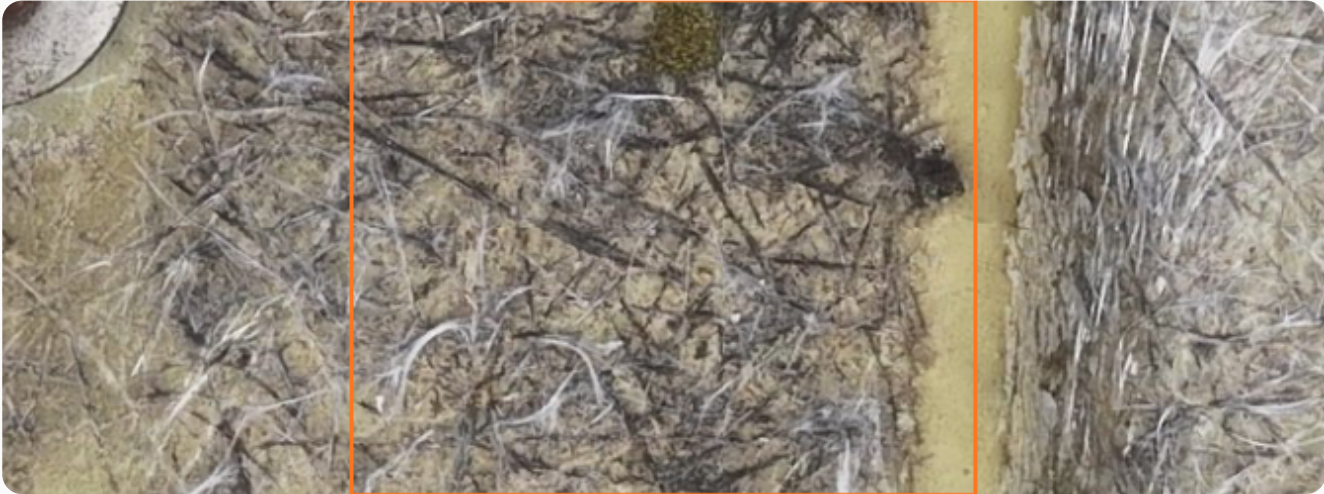
# 26

GRP roof lights are present throughout and are considered to be nearing the end of their serviceable lifespan. Prolonged exposure to ultraviolet (UV) radiation has caused the material to become brittle, increasing the likelihood of cracking, failure, and associated water ingress. In one instance, a roof light has failed completely, leaving an open point of ingress where water penetration into the building will be certain during periods of rainfall. The widespread ageing and deterioration of the roof lights indicates that further failures are likely if remedial works are not undertaken.

Severity 2

UV degradation

- Replace all deteriorated GRP roof lights with new units of equivalent specification
- Prioritise the roof light that has already failed completely
- Install all replacement roof lights with new seals, fixings, and weathering details
- Review the condition of surrounding roof sheets and support details during replacement works

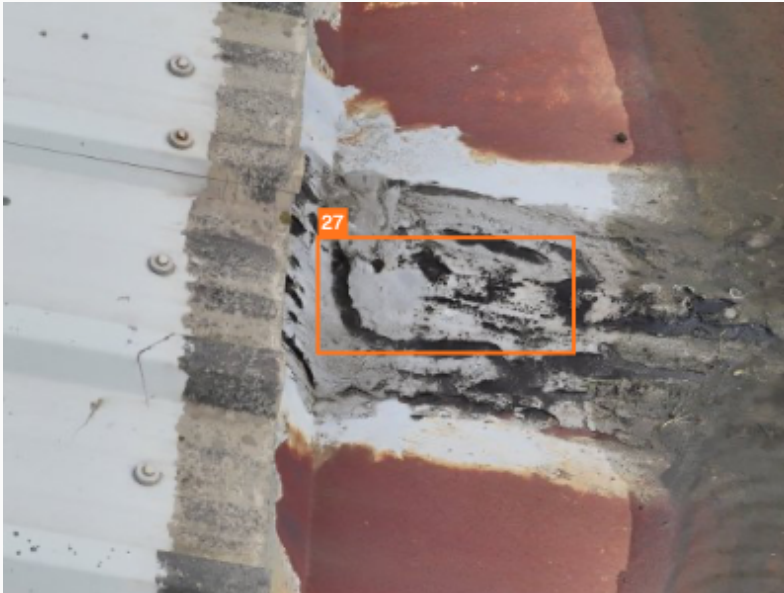
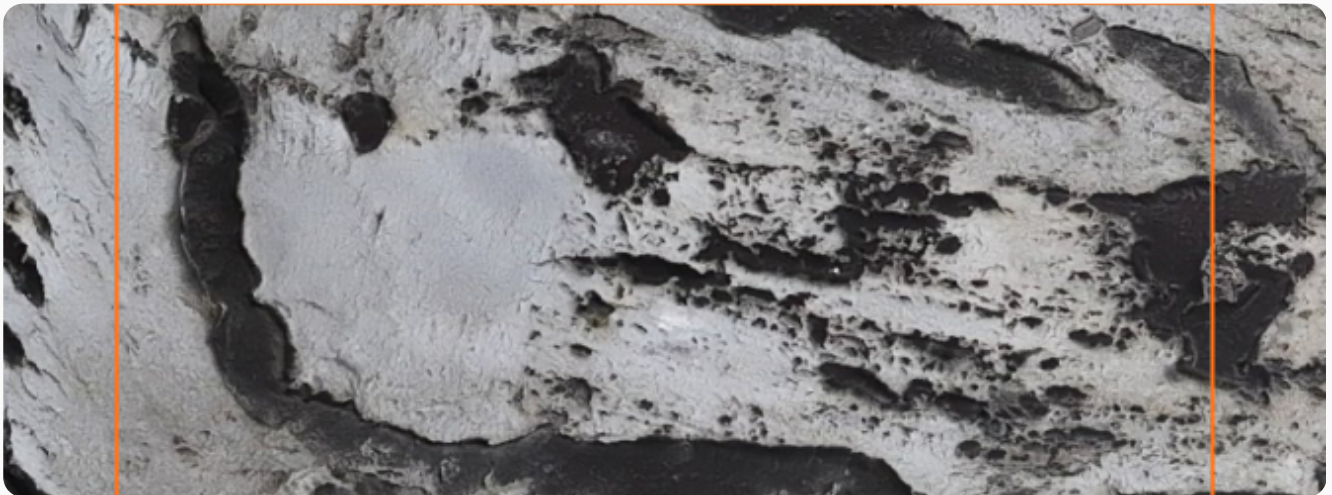
# 27

Severity 2

Existing repair
