## Thermal Survey Report – Solar PV Array

Location: [REDACTED]

Survey Date: 8th August 2025

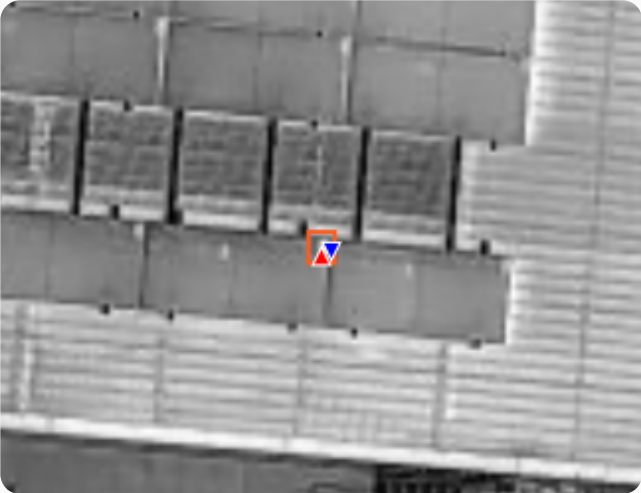
# 1

Severity 3

Hot Spot

Cell

📌 **Thermal Readings:**  
~Avg : 30.136°      Δ : 8.5°  
▲ : 34.5°      ▼ : 26°

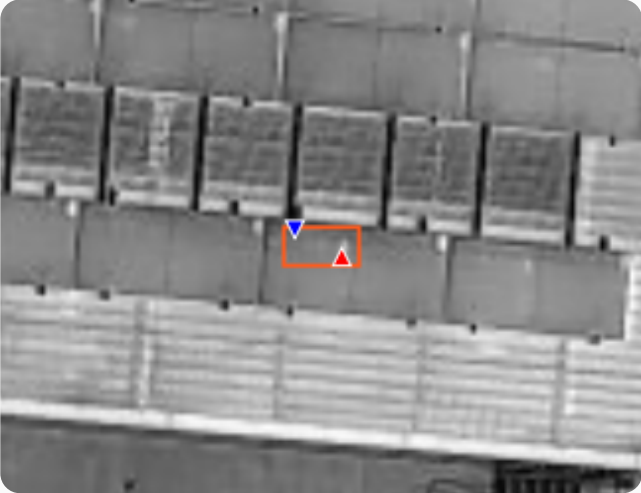
# 2

Severity 3

Hot Spot

Cell

📌 **Thermal Readings:**  
~Avg : 27.603°      Δ : 9.3°  
▲ : 30.3°      ▼ : 21°

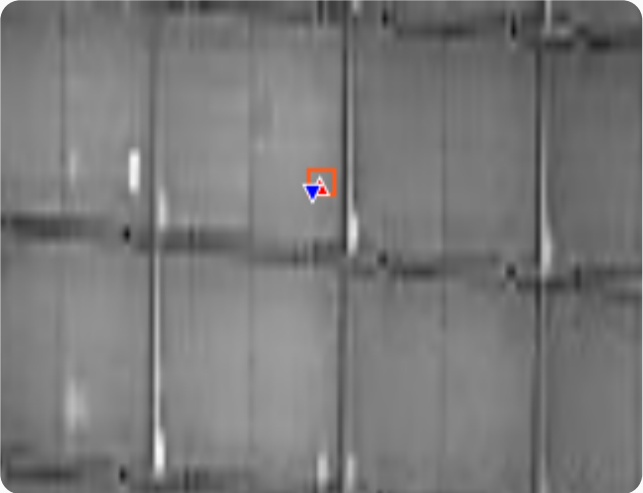
# 21

Severity 3

Hot Spot

Cell

📌 **Thermal Readings:**  
~Avg : 31.977°      Δ : 3.2°  
▲ : 33.7°      ▼ : 30.5°

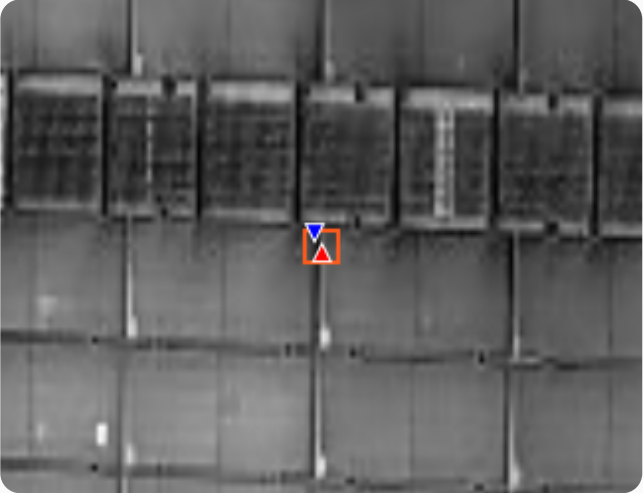
# 22

Severity 3

Hot Spot

Cell

📌 **Thermal Readings:**  
~Avg : 30.845°      Δ : 6.5°  
▲ : 35°      ▼ : 28.5°

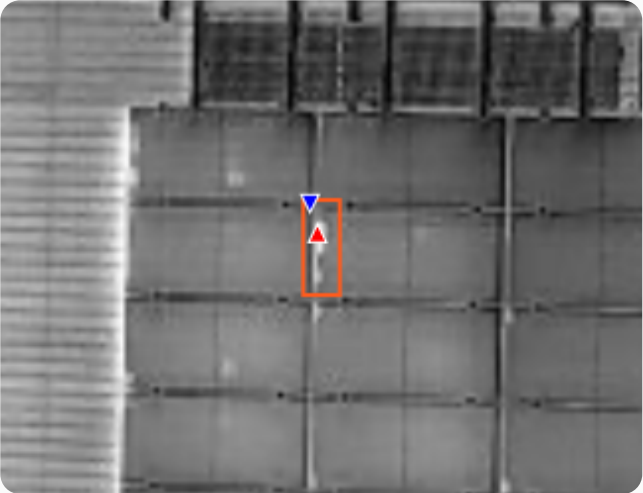
# 30

Severity 3

Hot Spot

Cell

**Thermal Readings:**  
~Avg : 31.656°      Δ : 9°  
▲ : 37.6°      ▼ : 28.6°

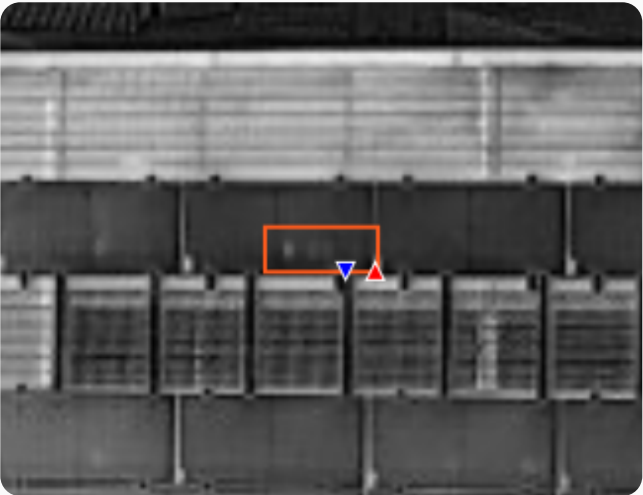
# 31

Severity 3

Hot Spot

Cell

**Thermal Readings:**  
~Avg : 25.822°      Δ : 6.4°  
▲ : 29.2°      ▼ : 22.8°
