## Thermal Survey Report – Solar PV Array

Location: [REDACTED]

Survey Date: 8th August 2025

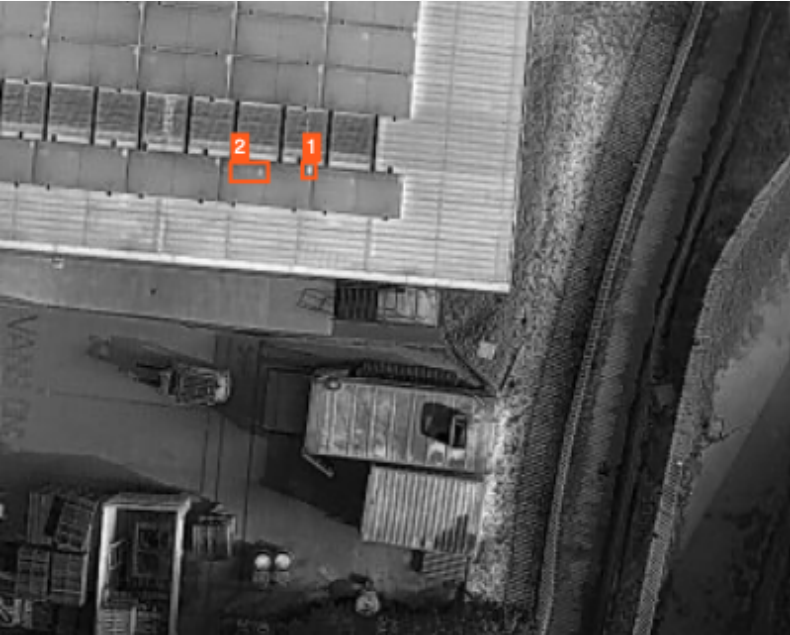
DJI\_20250808164435\_0026\_T.JPG  
2025:08:08 16:44:35

# 1

Severity 3

Hot Spot

Cell

📌 **Thermal Readings:**  
~Avg : 30.136°      Δ : 8.5°  
▲ : 34.5°      ▼ : 26°

# 2

📌 **Thermal Readings:**  
~Avg : 27.603°      Δ : 9.3°  
▲ : 30.3°      ▼ : 21°

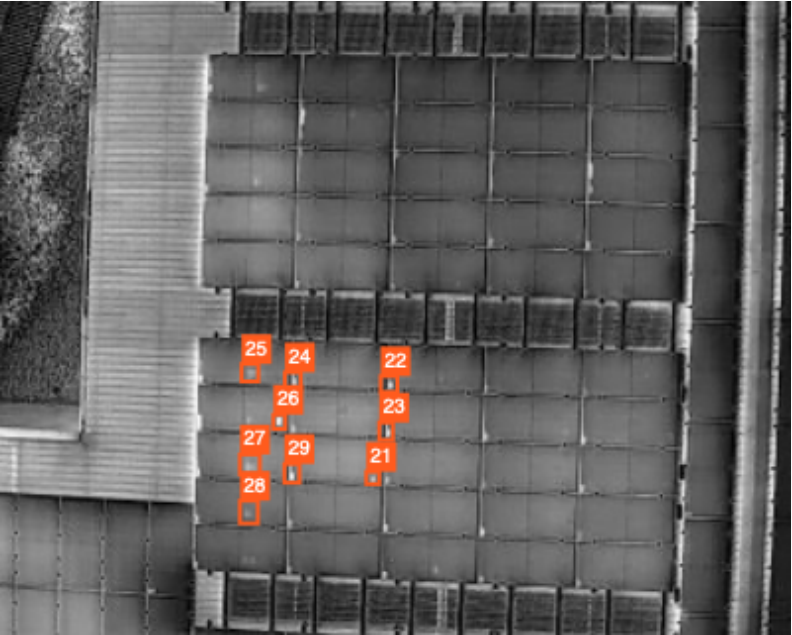
DJI\_20250808164536\_0042\_T.JPG  
2025:08:08 16:45:36

# 21

Severity 3

Hot Spot

Cell

📌 **Thermal Readings:**  
~Avg : 31.977°      Δ : 3.2°  
▲ : 33.7°      ▼ : 30.5°

# 22

📌 **Thermal Readings:**  
~Avg : 30.845°      Δ : 6.5°  
▲ : 35°      ▼ : 28.5°

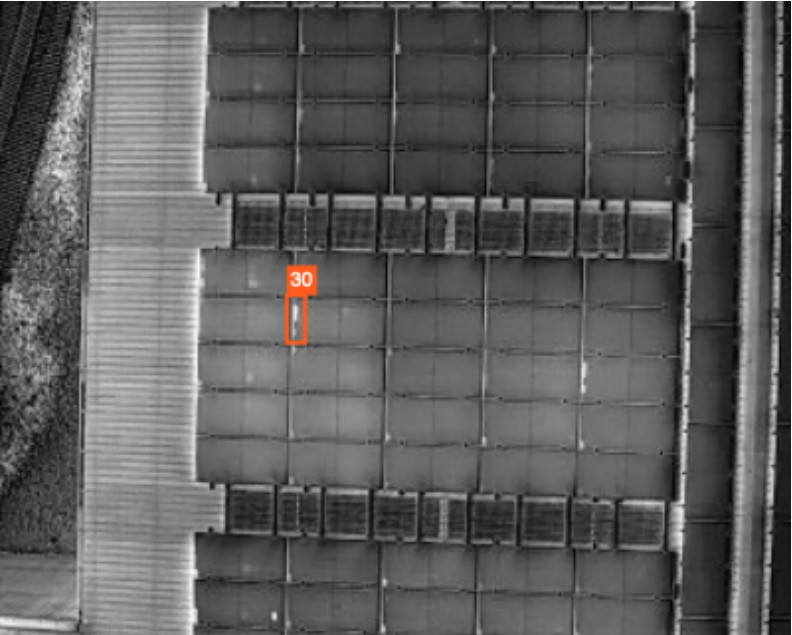
DJI\_20250808164540\_0043\_T.JPG  
2025:08:08 16:45:40

# 30

Severity 3

Hot Spot

Cell

**Thermal Readings:**  
~Avg : 31.656°      Δ : 9°  
▲ : 37.6°      ▼ : 28.6°
